Northern Suburbs Football Association: Playing field assessments

August 2016

Playing field assessments

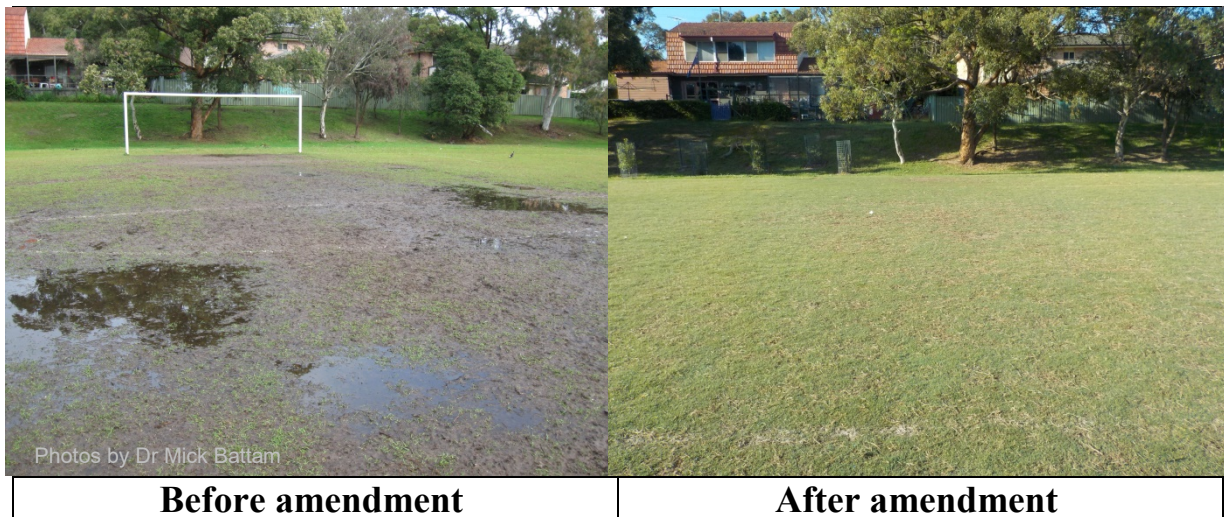
Figure E-2: The impact of amendment works on the October condition of Kareela no. 4 sporting field which receives similar levels of wear to Norman Griffith Oval.

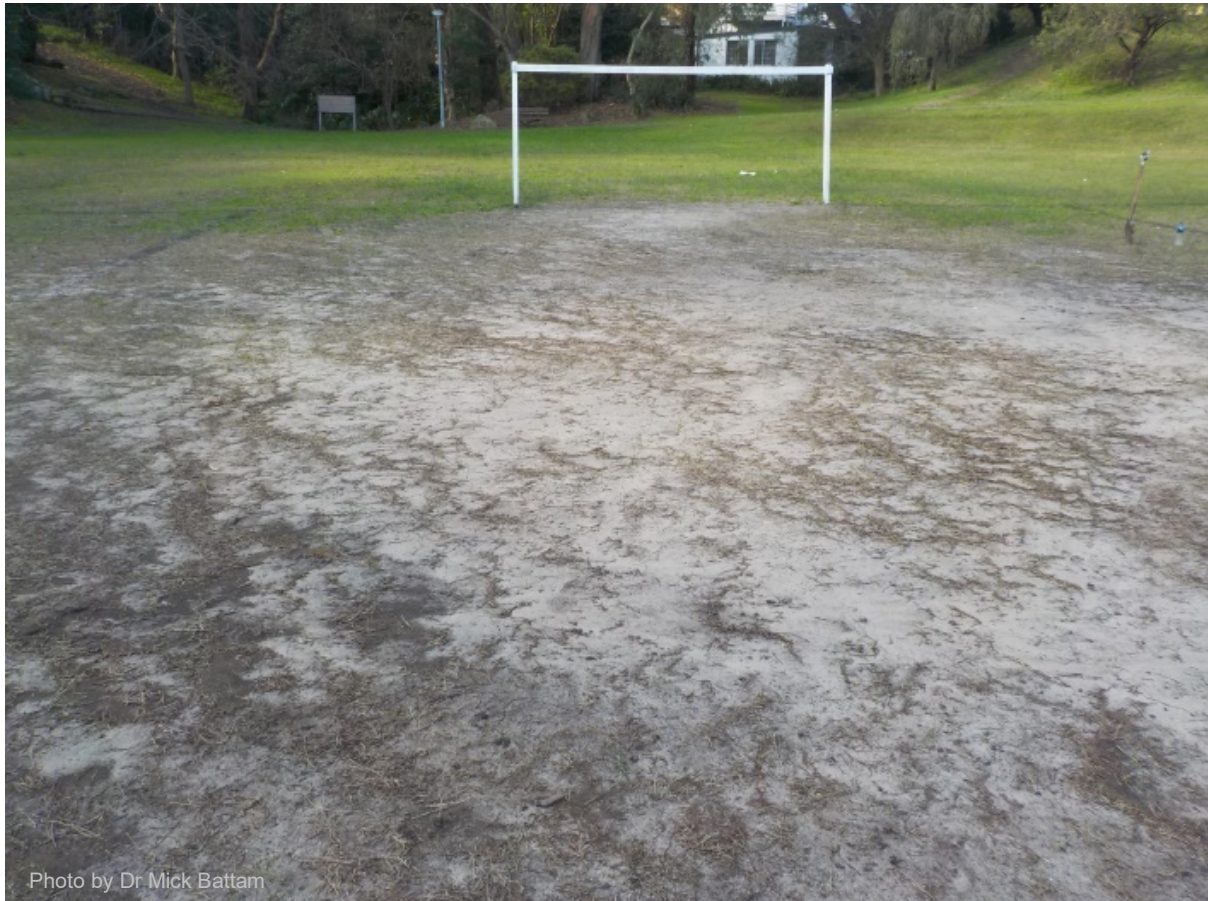
Figure 2-2: Thin cover on Loyal Henry Park due primarily to poor soil. Acceptable turf cover will not be achieved in this area by the end of summer unless turf patching is performed.

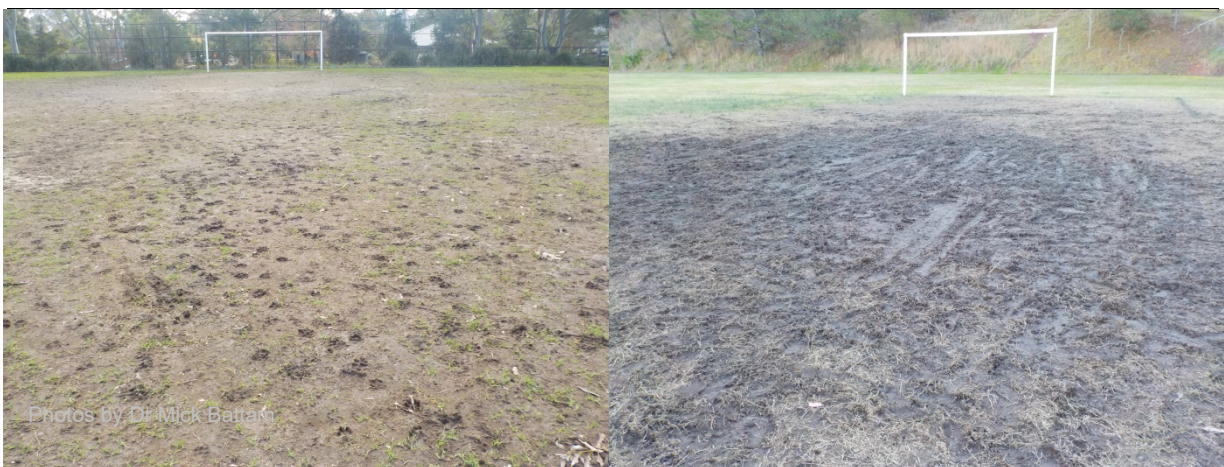
Figure 3-1: Low levels of traction at Queen Elizabeth Reserve (left) and The Glade (right).

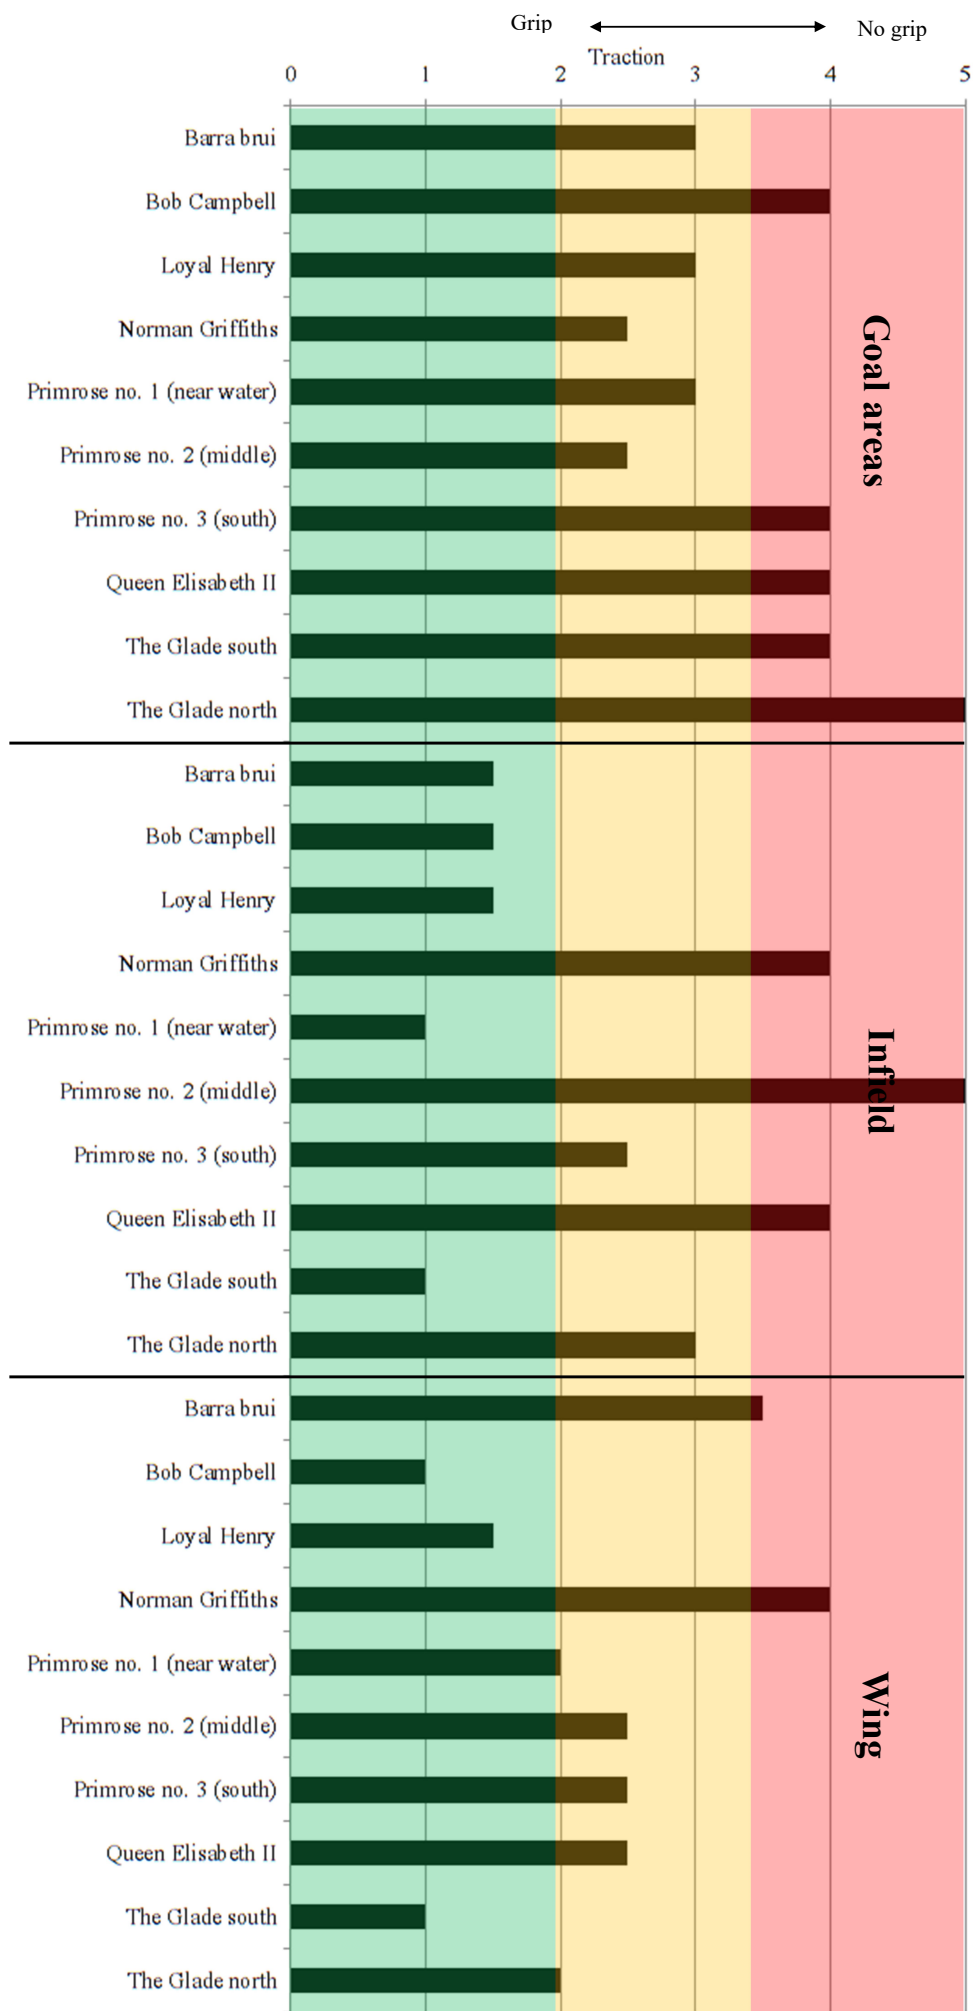
Traction refers to the amount of grip that the playing surface provides to players. Low levels of traction are generally associated with sandy soils, waterlogged areas, thin turf and/or root problems. The parameter has been subjectively scored on a scale of 0 (grip) to 5 (minimal grip). Sites with a score of more than 3.5 are regarded as unacceptable, which was observed on all sites, being worst at (Figure 3.2):

Figure 3-2 Playing surface traction on different sections of the playing fields. Colours show optimal (green), acceptable (orange) and unacceptable (red) scores for traction.

Techniques for improving traction have been encapsulated in the site renovation (Chapter 4) and maintenance practices (Chapter 5).

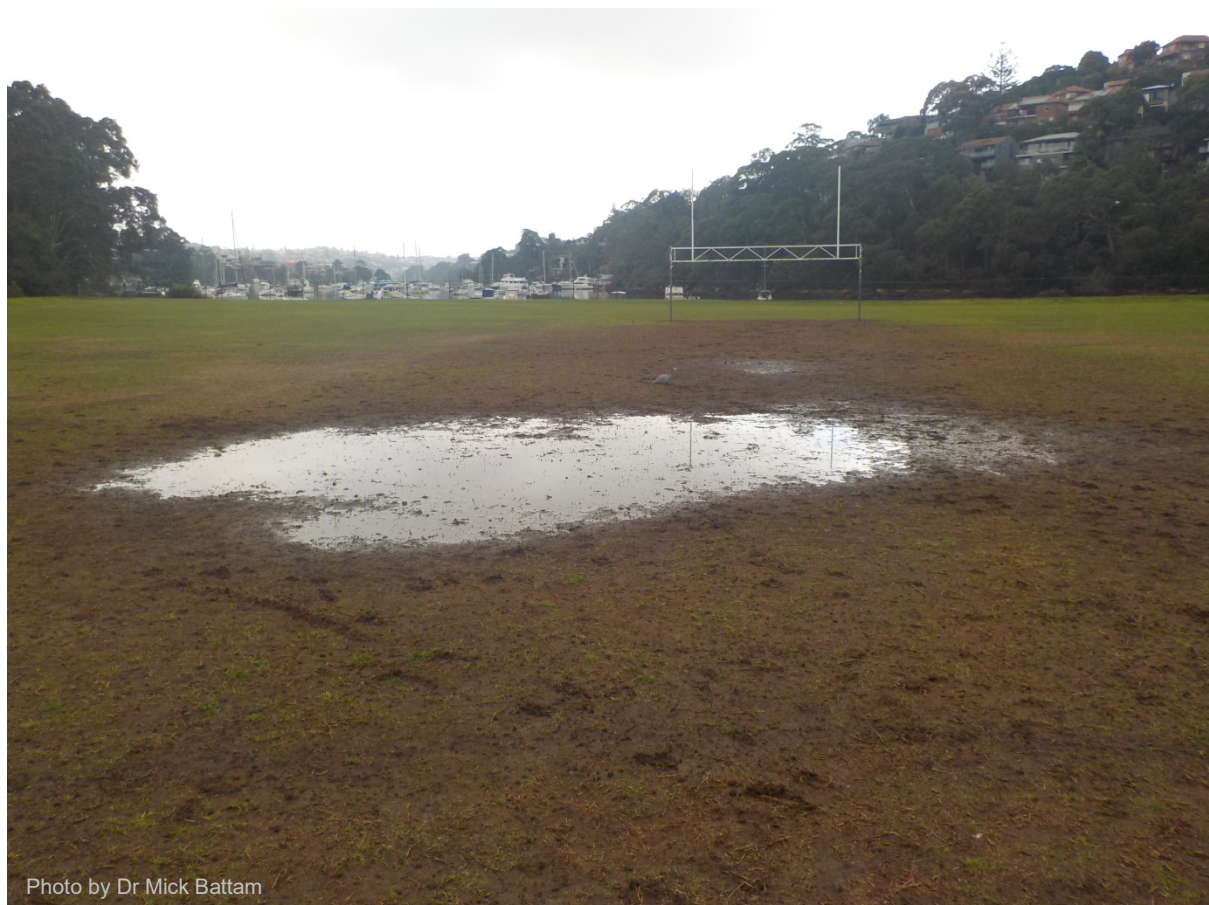
Figure 3-3 Water lying in a low spot on Primrose Park.

Topdressing will improve surface evenness and this has been recommended for several sites (Table 4.1). Depressions on most fields should be gradually filled by topdressing with a mixture of 50% loamy sand (Appendix H) and 50% compost (Appendix I).

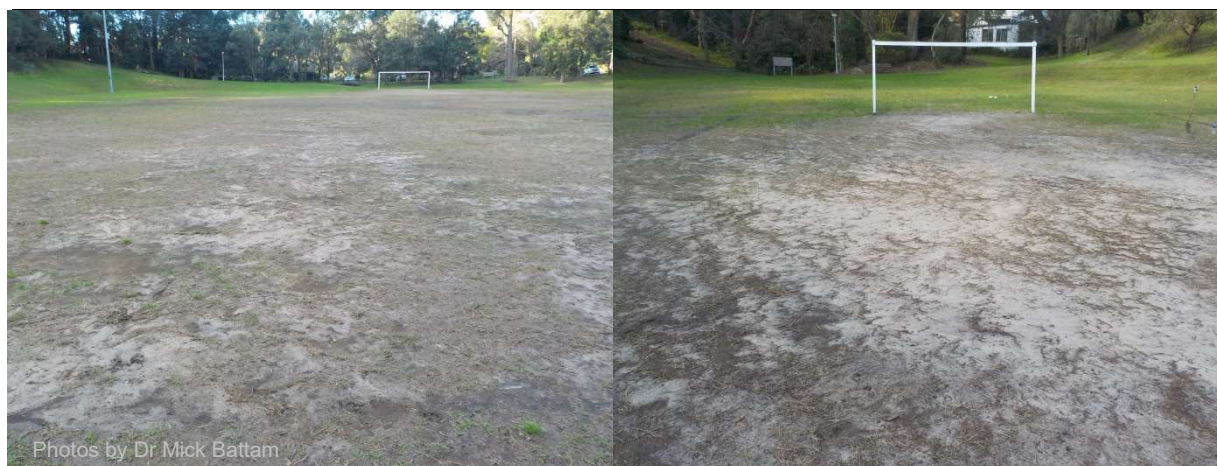
Figure 3-7: Thin turf cover at Norman Griffith Oval (left) and Loyal Henry Park (right).

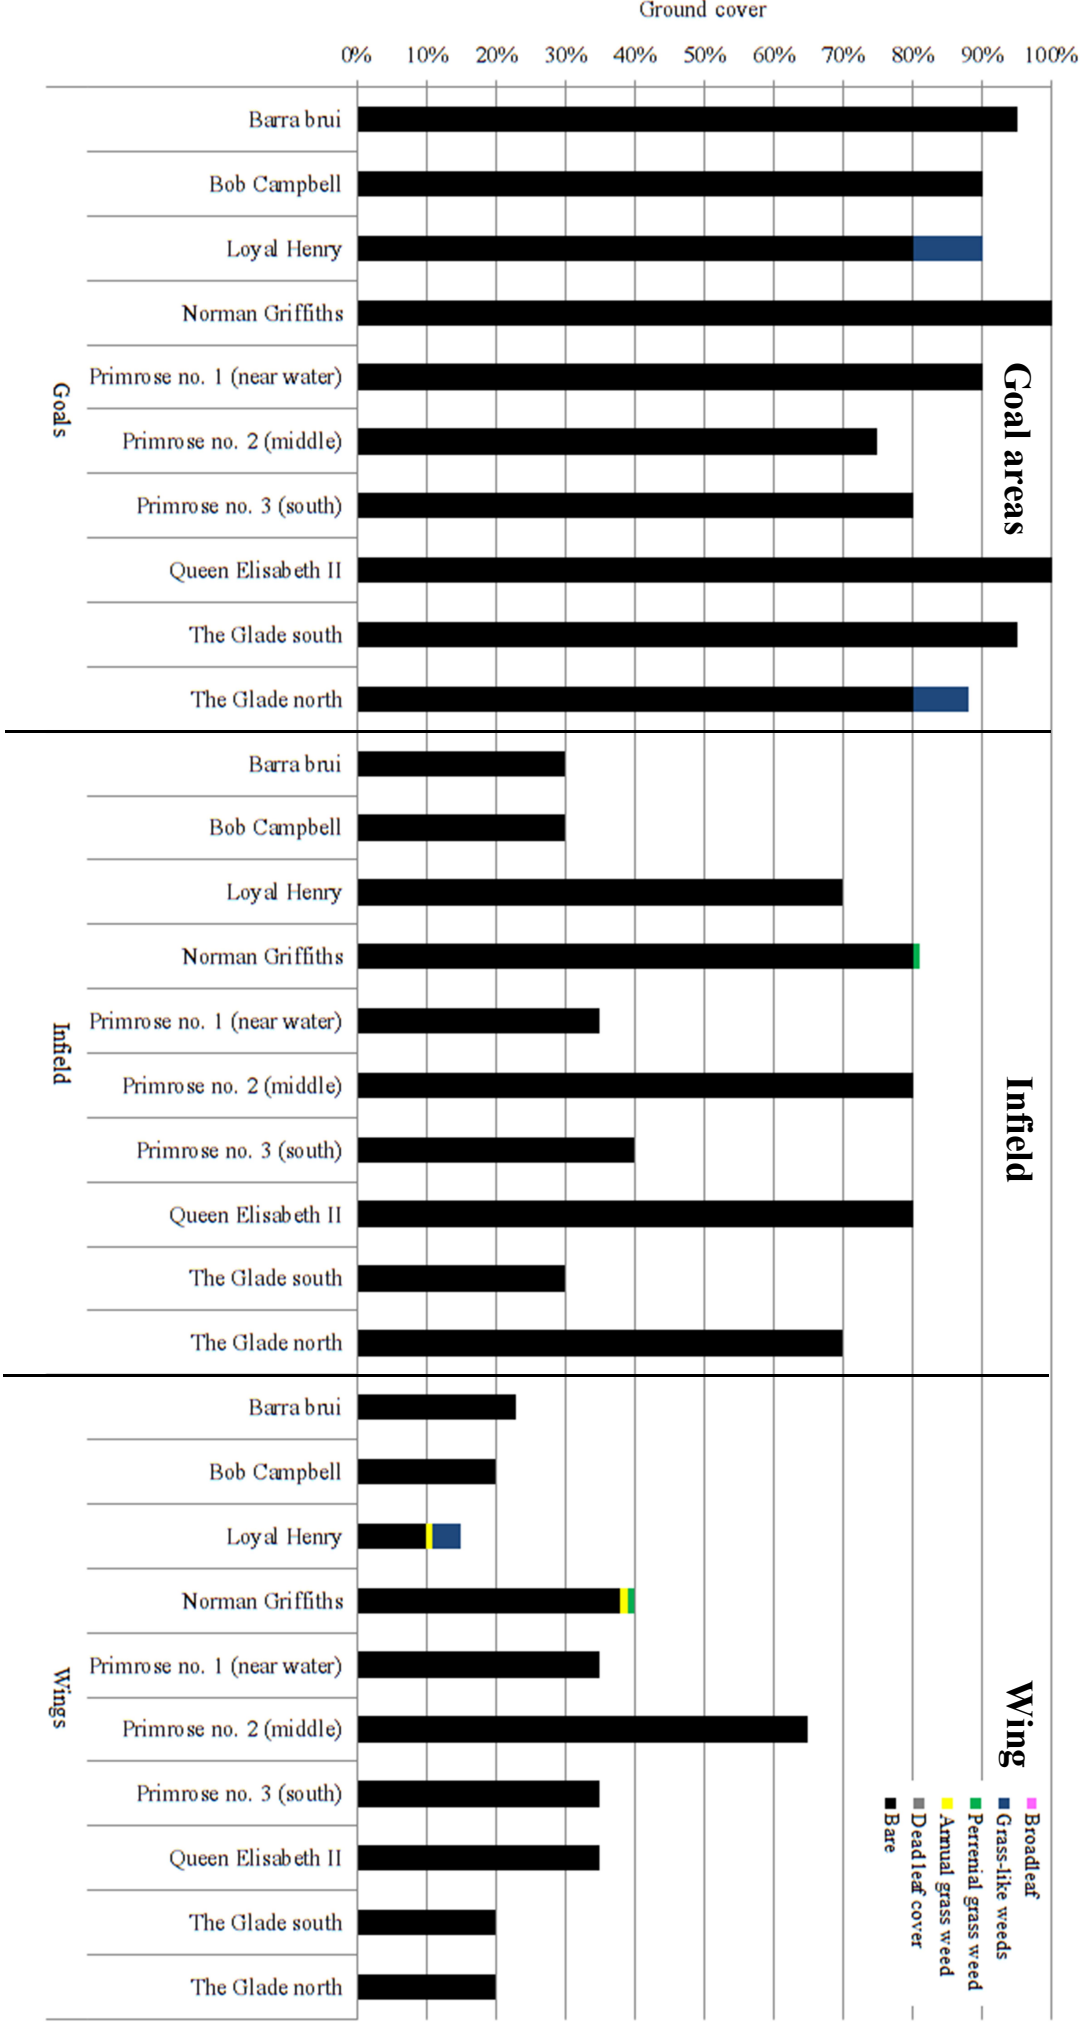
Even though the usage levels were generally not extreme many of the fields were struggling to maintain acceptable turf cover (Figure 3.9), with very poor cover observed at:

Figure 3-9 Percentage bare ground and weed cover observed on the fields during the site inspections.

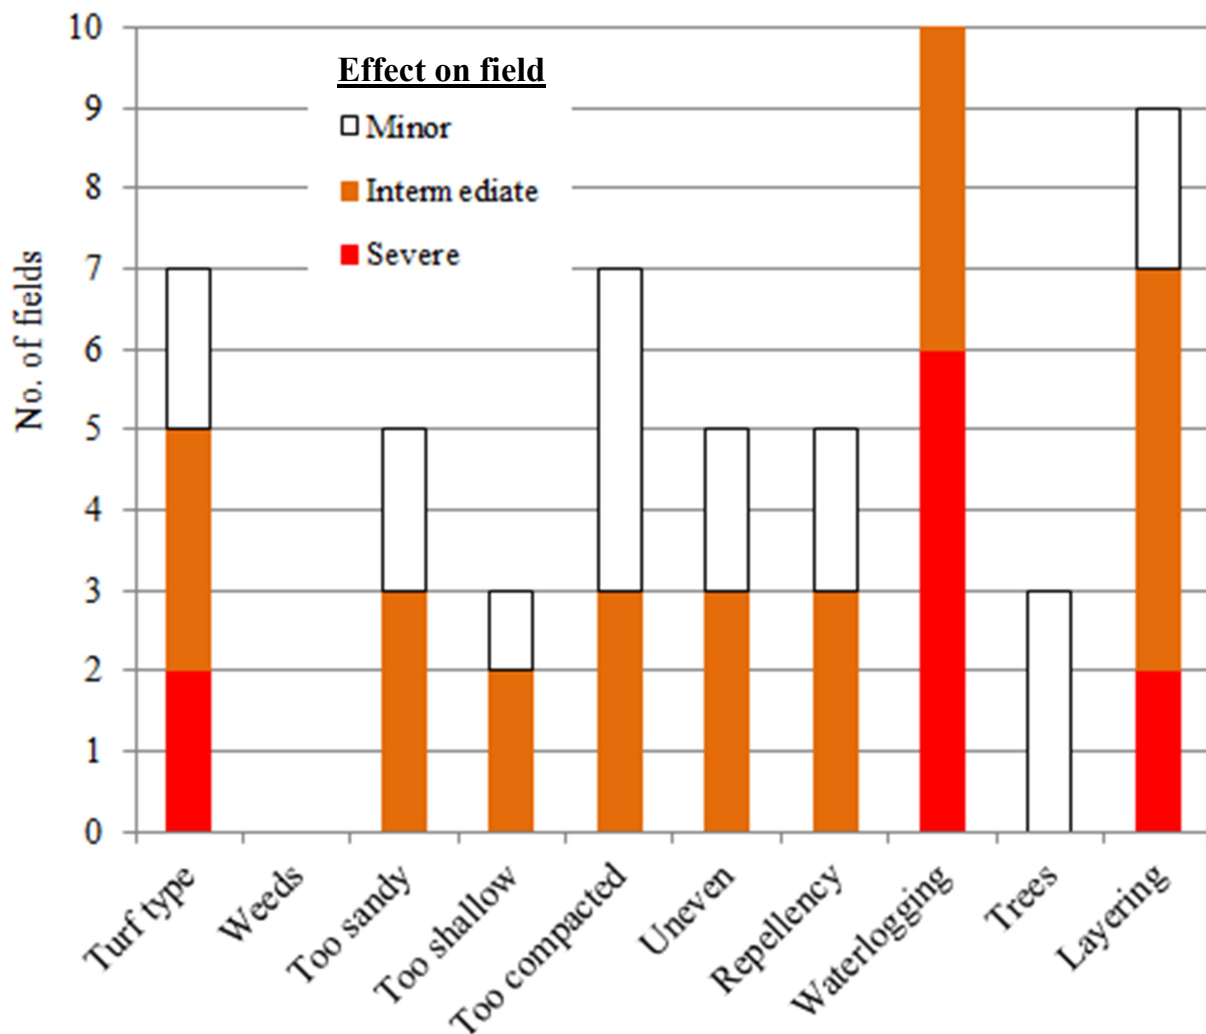
Figure 4-1 Factors limiting turf growth on the 10 winter playing fields (7 sites), many of which had multiple problems.

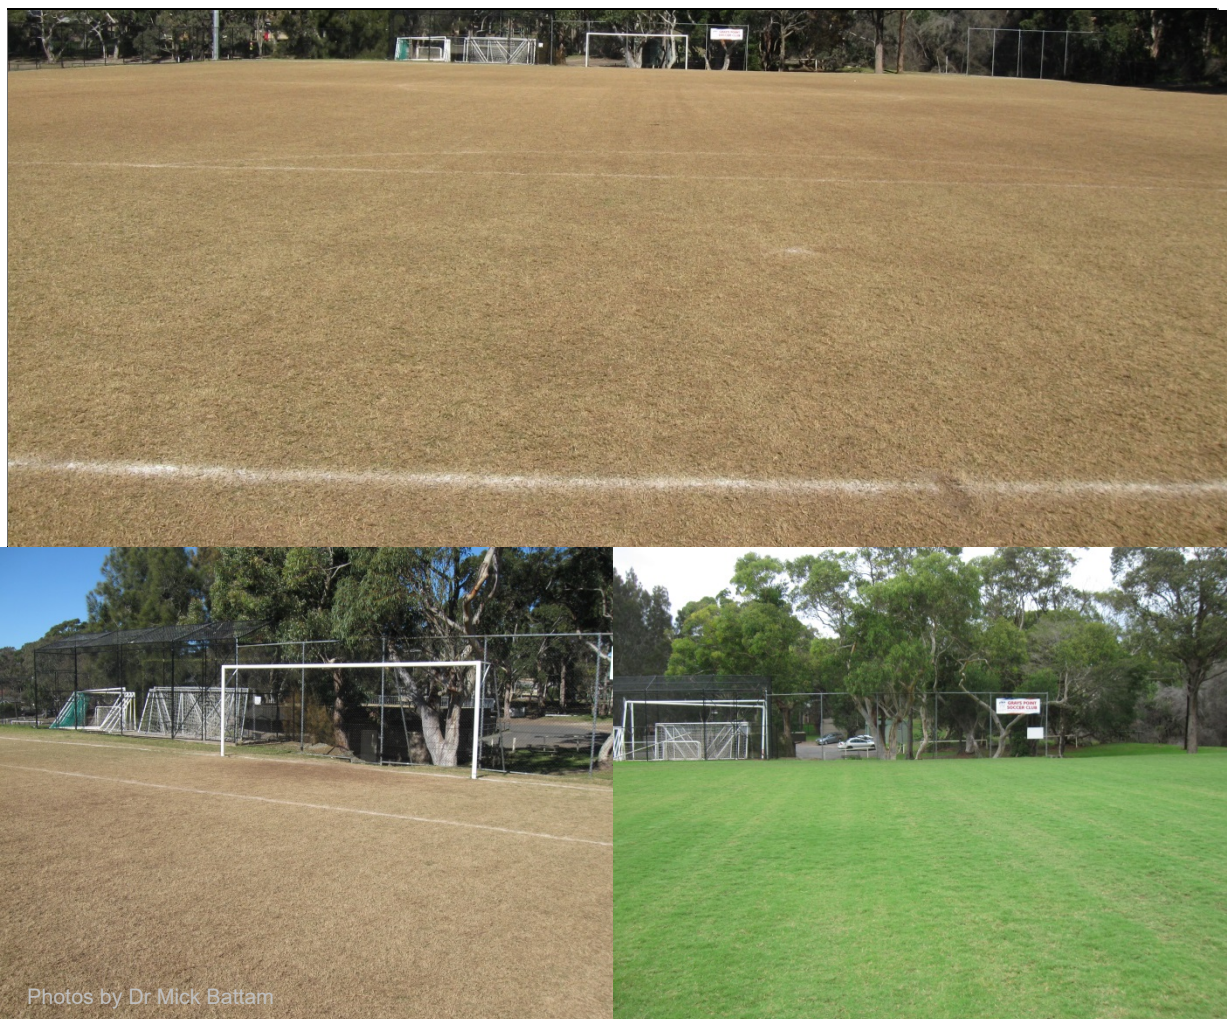
Figure 4-2: Heavily used couch sporting field at Greys Point that becomes dull coloured at the end of the winter sport season (upper), but maintains acceptable cover even in goal boxes (lower left) and rapidly recovers to be in excellent condition by October (lower right).

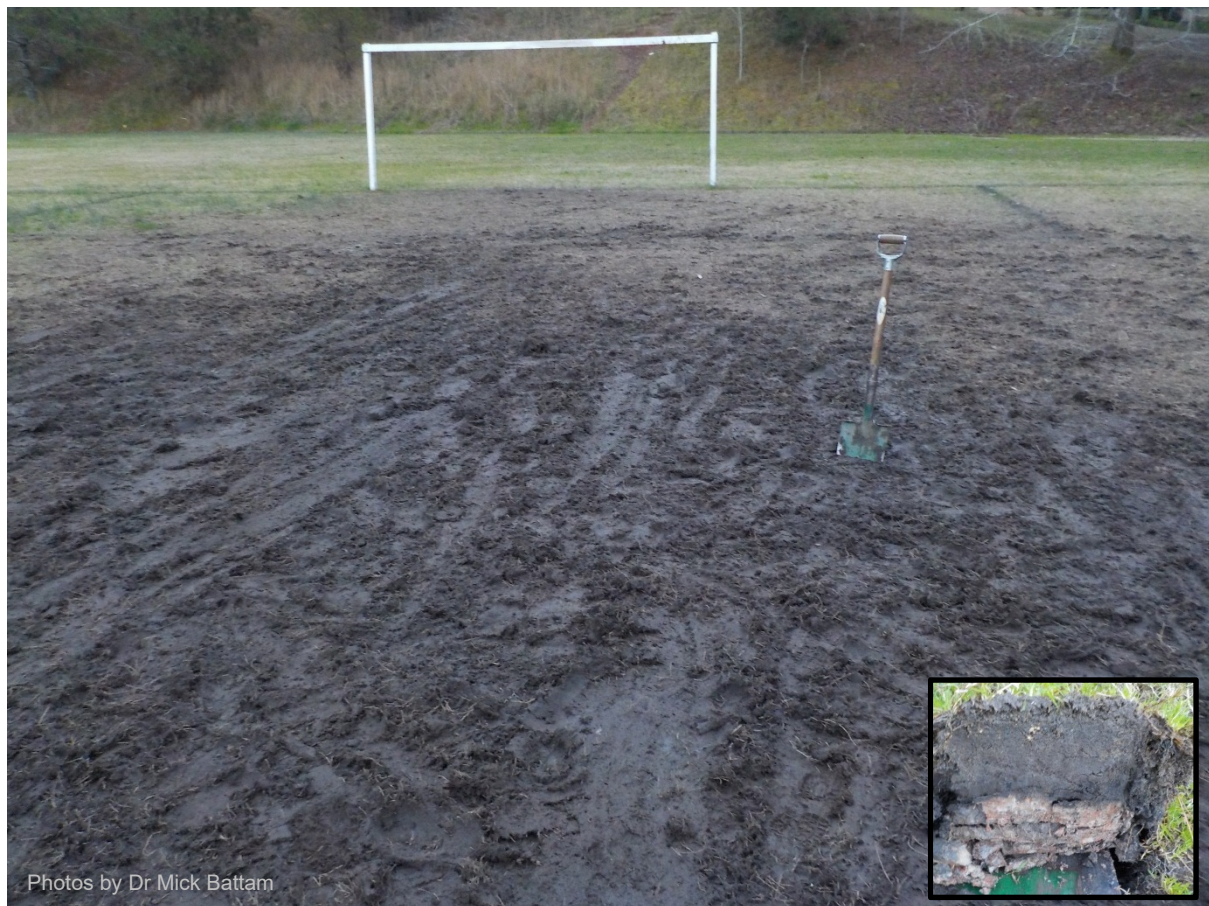
Figure 4-3 The turf struggling on a shallow section of The Glade. As the subsoil has a heavy clay texture (insert) this shallow area is also prone to waterlogging.

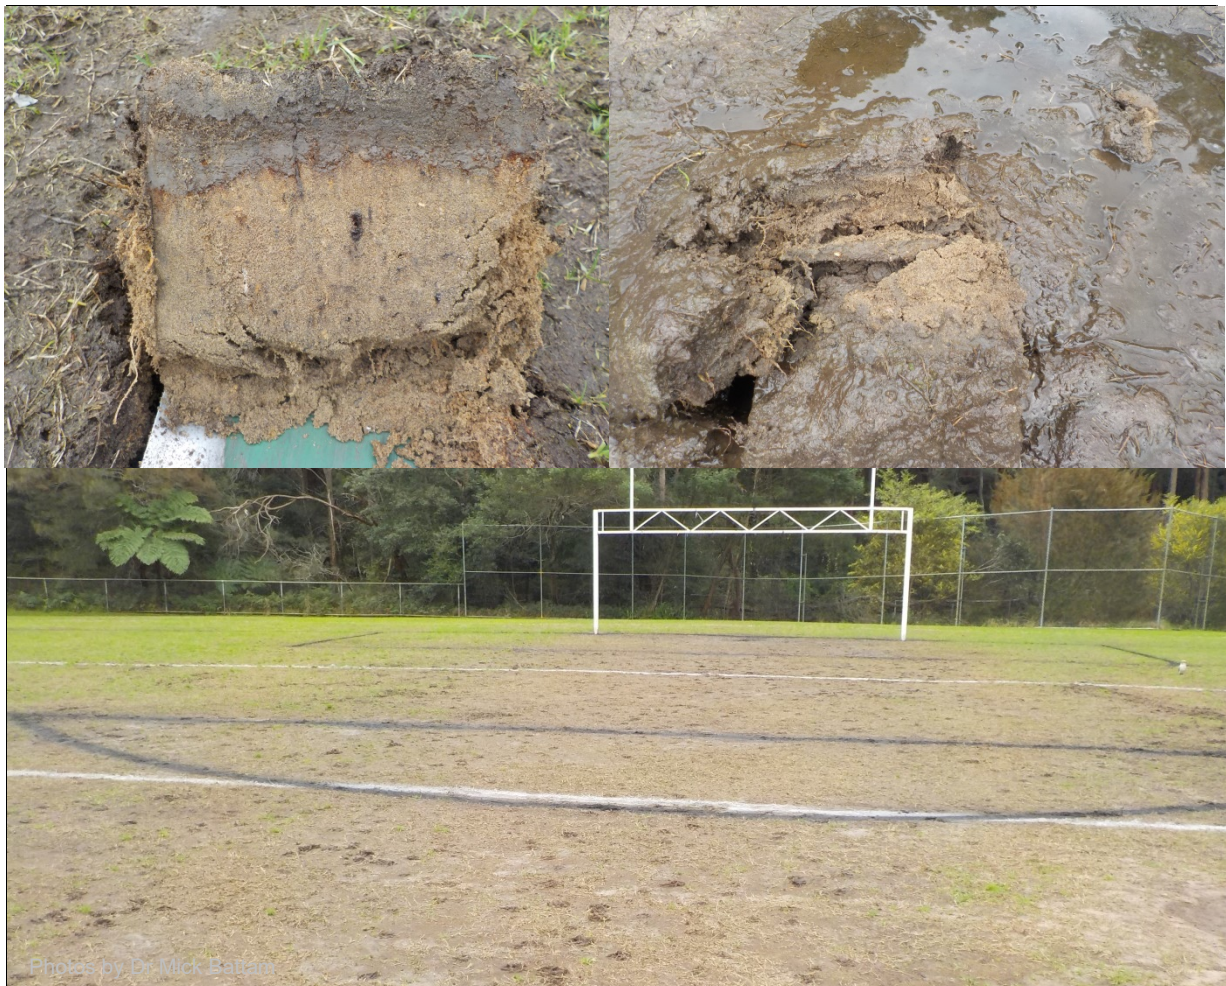
Figure 4-4: The surface is soft following rain on Barra Brui Oval (lower) due to slow infiltration through the thin layer of soil imported to the site attached to turf rolls (upper left), with the underlying sand remaining relatively dry even when there is water sitting on the surface (upper right).

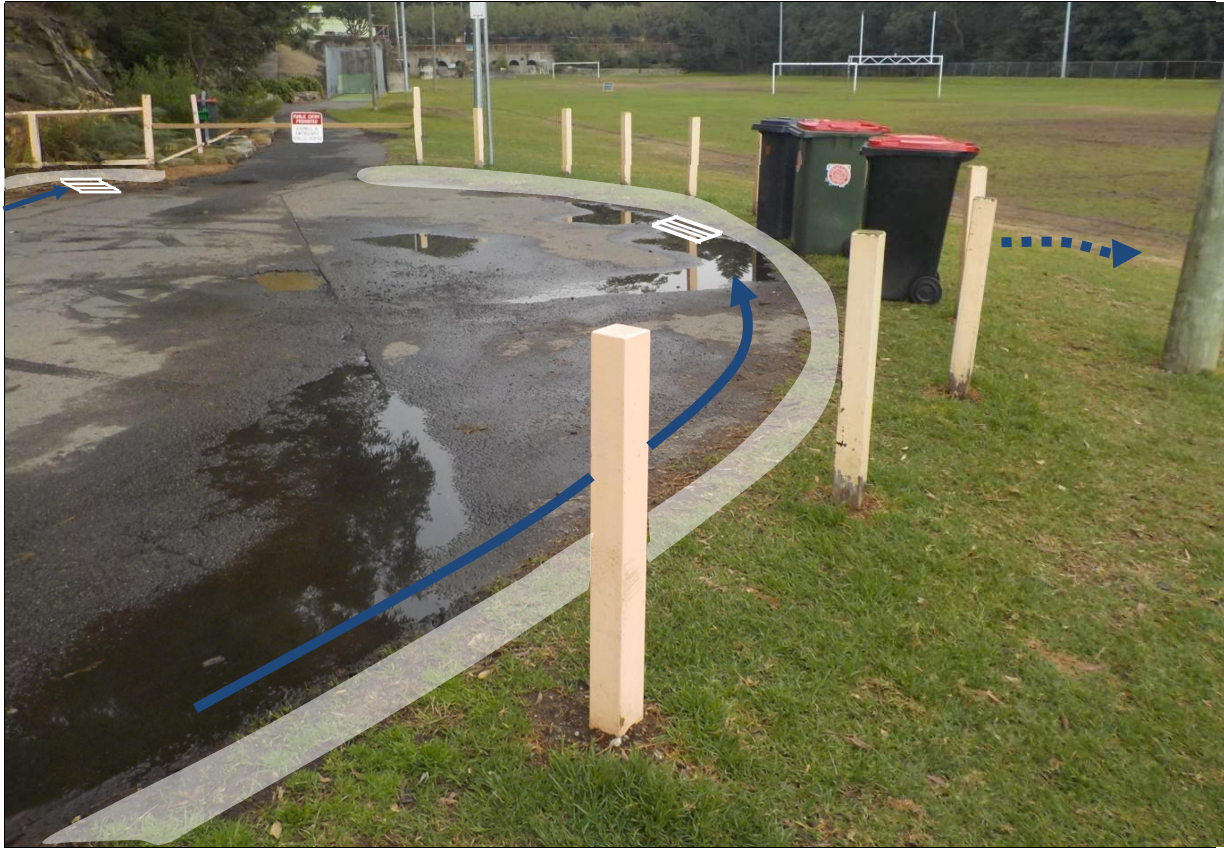
Figure 4-5: Water running onto Primrose Park (dashed arrow) that should be intercepted using surface pits, with a gutter (or dish drain) needed to divert water into the pits at the end of Denos Lane. It may also be necessary to install a dish drain or speed hump to prevent water running through the vehicle entry gate and onto the fields.

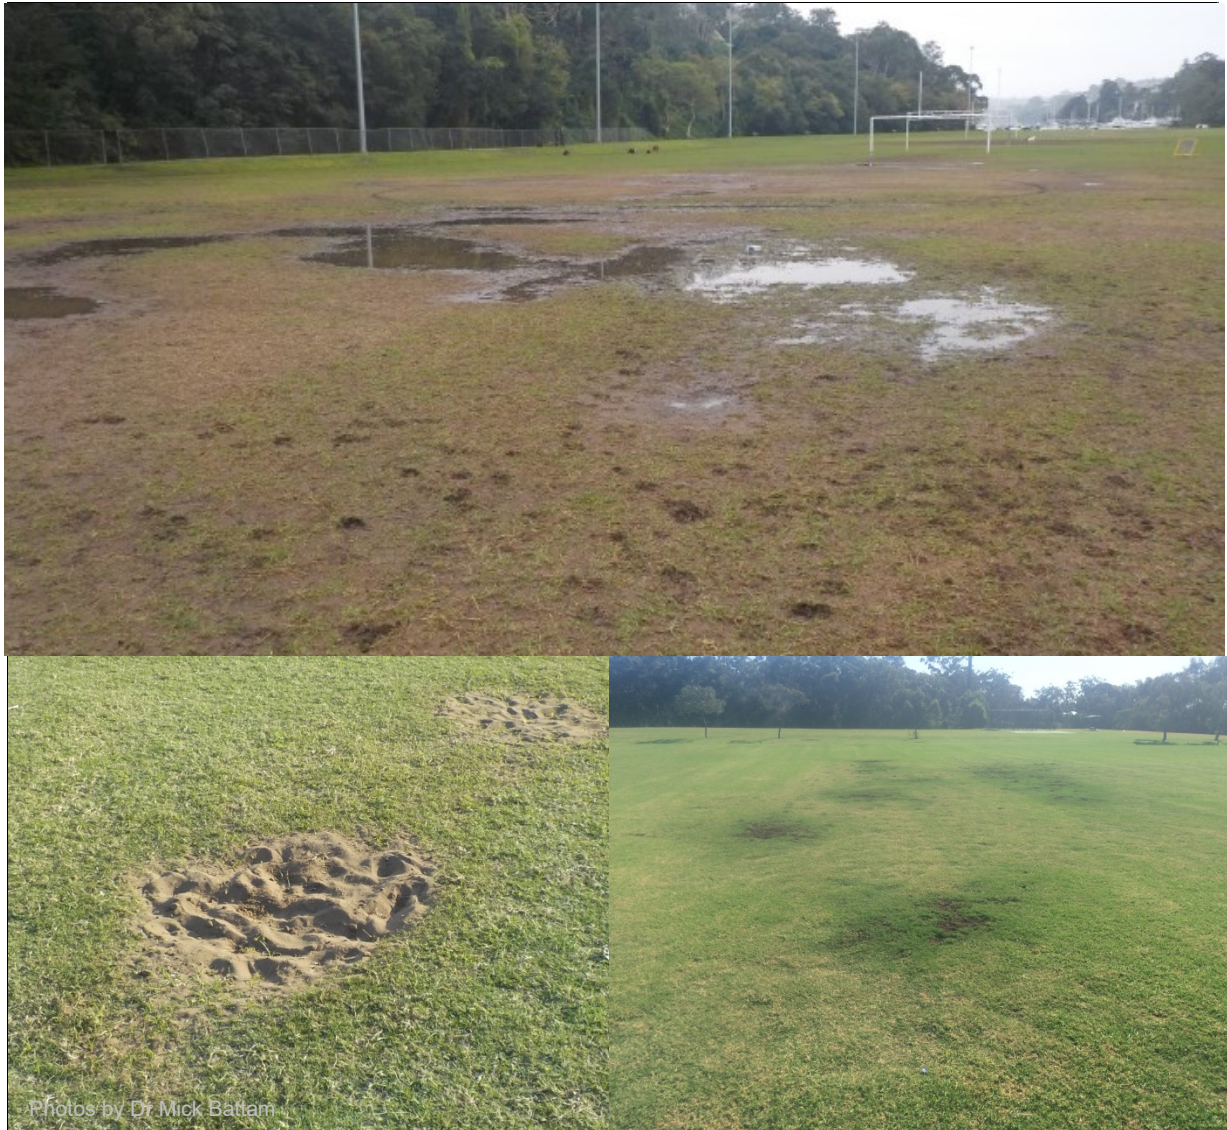
Figure 4.6: Waterlogging caused by unevenness in the surface (upper) should not be addressed by filling these areas with sand as the turf will remain thin and these areas which will erode (lower left). Instead these depressions should be gradually filled by topdressing with a mixture of 50% loamy sand and 50% AS 4454 compost so the surface remains stable as the turf grows into these areas (lower right). Note the green tinge where compost/loamy sand topdress has been spread.

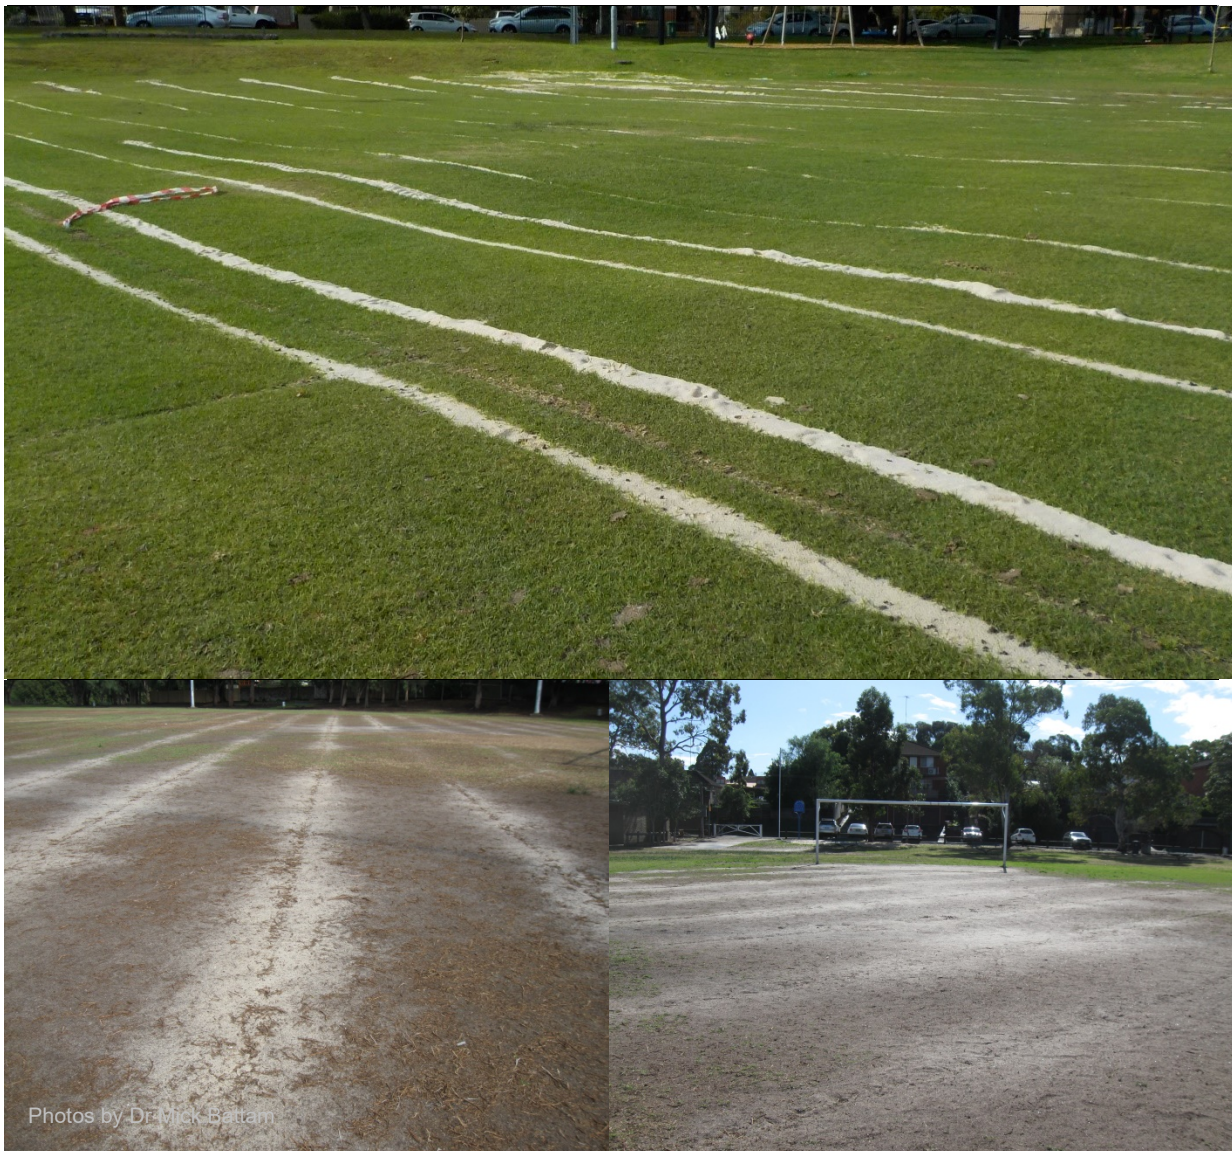
Figure 4-7: Slit drainage systems have been recommended for installation on a few sites, but must NOT be installed until the surface is even, soil has been amended and the site converted to an appropriate turf cultivar. Failure to ensure these criteria are met can make it difficult to address unevenness (upper) or lead to major damage to the slit drainage system just months after installation (lower).

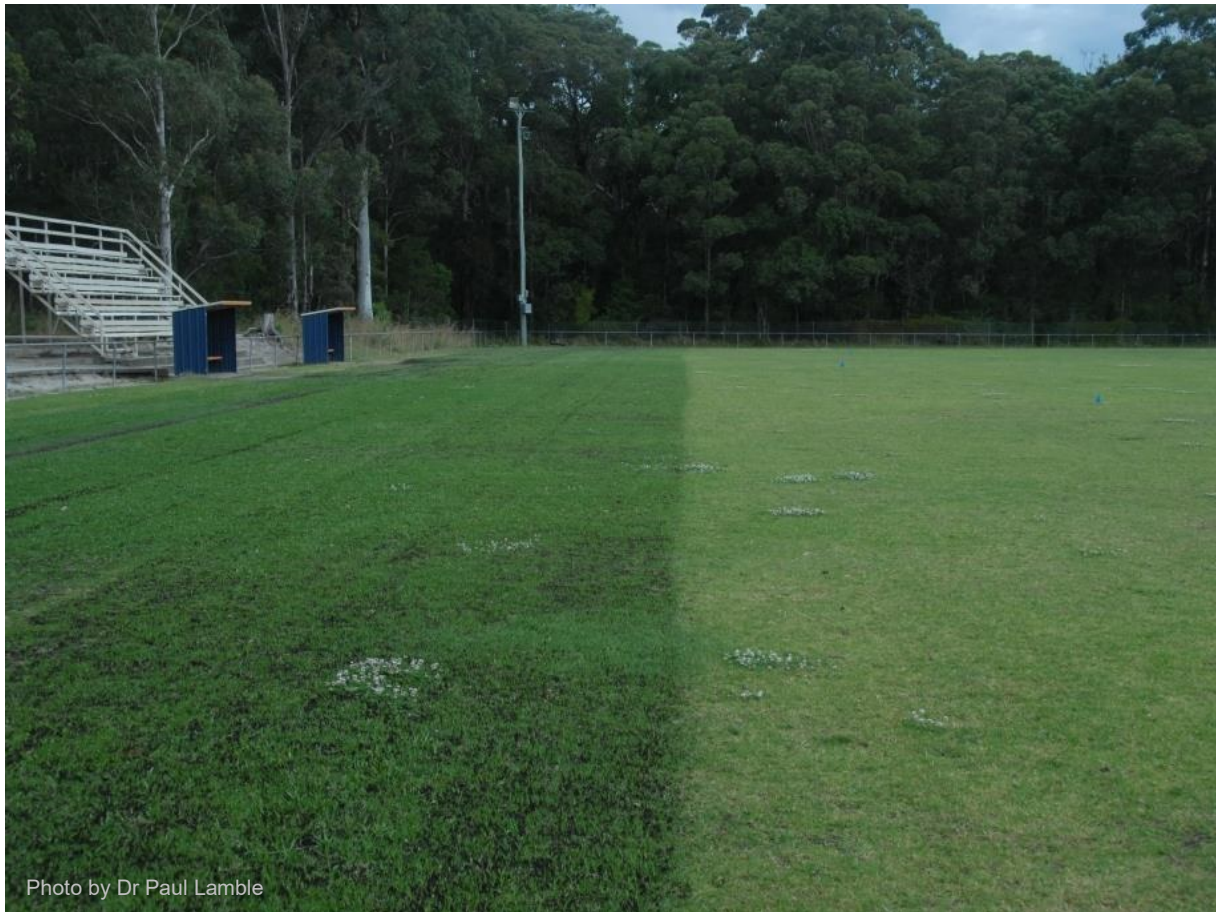
Figure 5.1: The effect of topdressing with AS 4454 composted garden organics on a sporting field in Lake Macquarie (photo courtesy of Dr Paul Lamble).

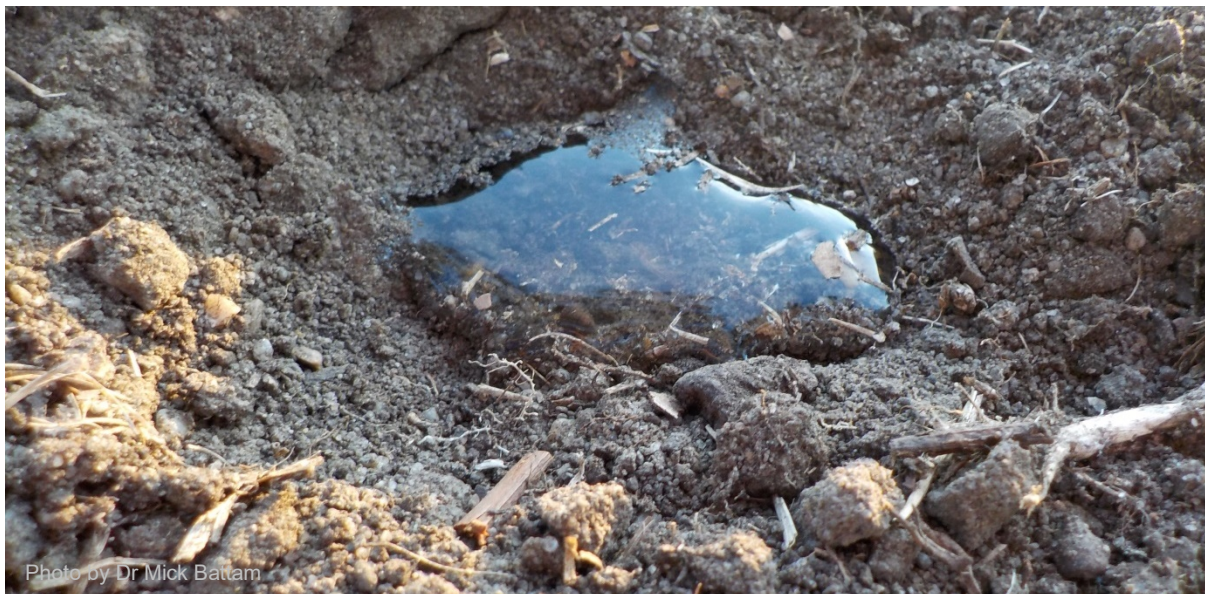
Figure 5-2 Water sitting like a “ball” on top of the soil as a result of waxes/fats in the soil that cause it to repel water.

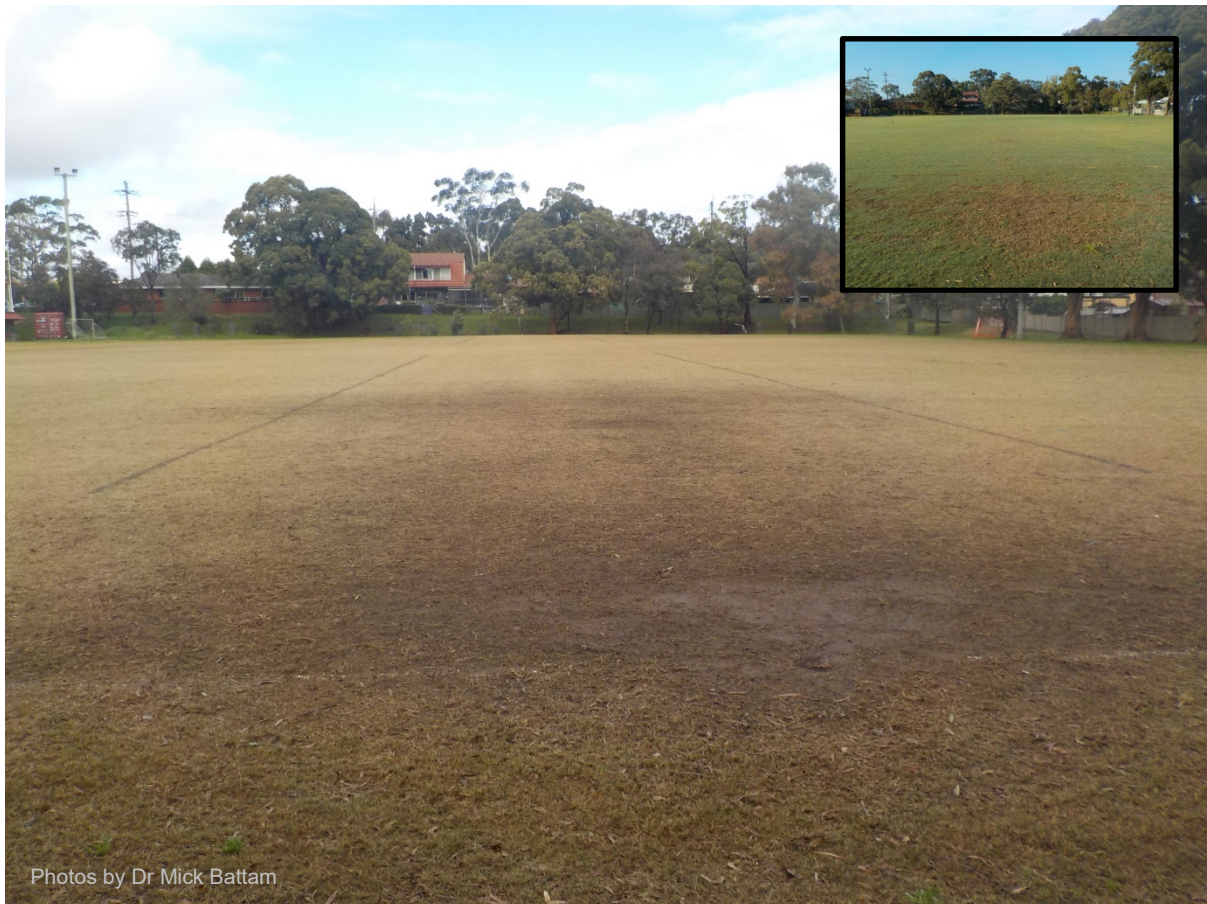
Figure 5-5: Example of a heavily used field (similar usage to Norman Griffith Oval) that has been amended so acceptable turf cover is maintained up to the end of the soccer season. However, the small bare area wear the goal keeper stands should be repaired at the start of spring so it fully recovers prior to the commencement of the next winter sport season.

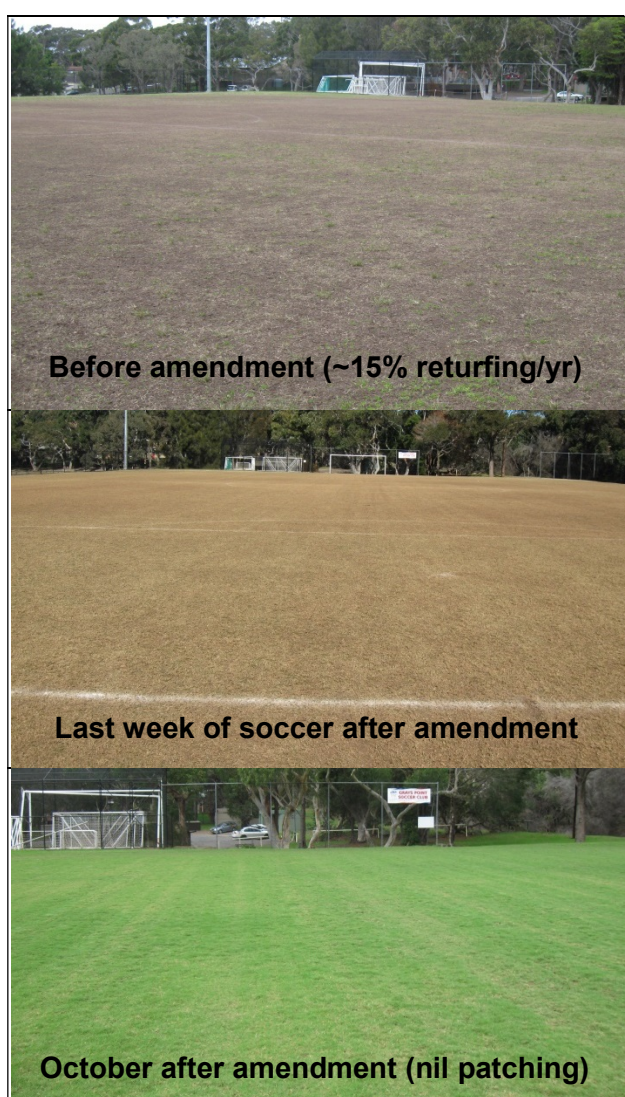
Figure 6.1: Effect of soil amendment works on Grays Point upper playing field which receives similar levels of use to Norman Griffith Oval.

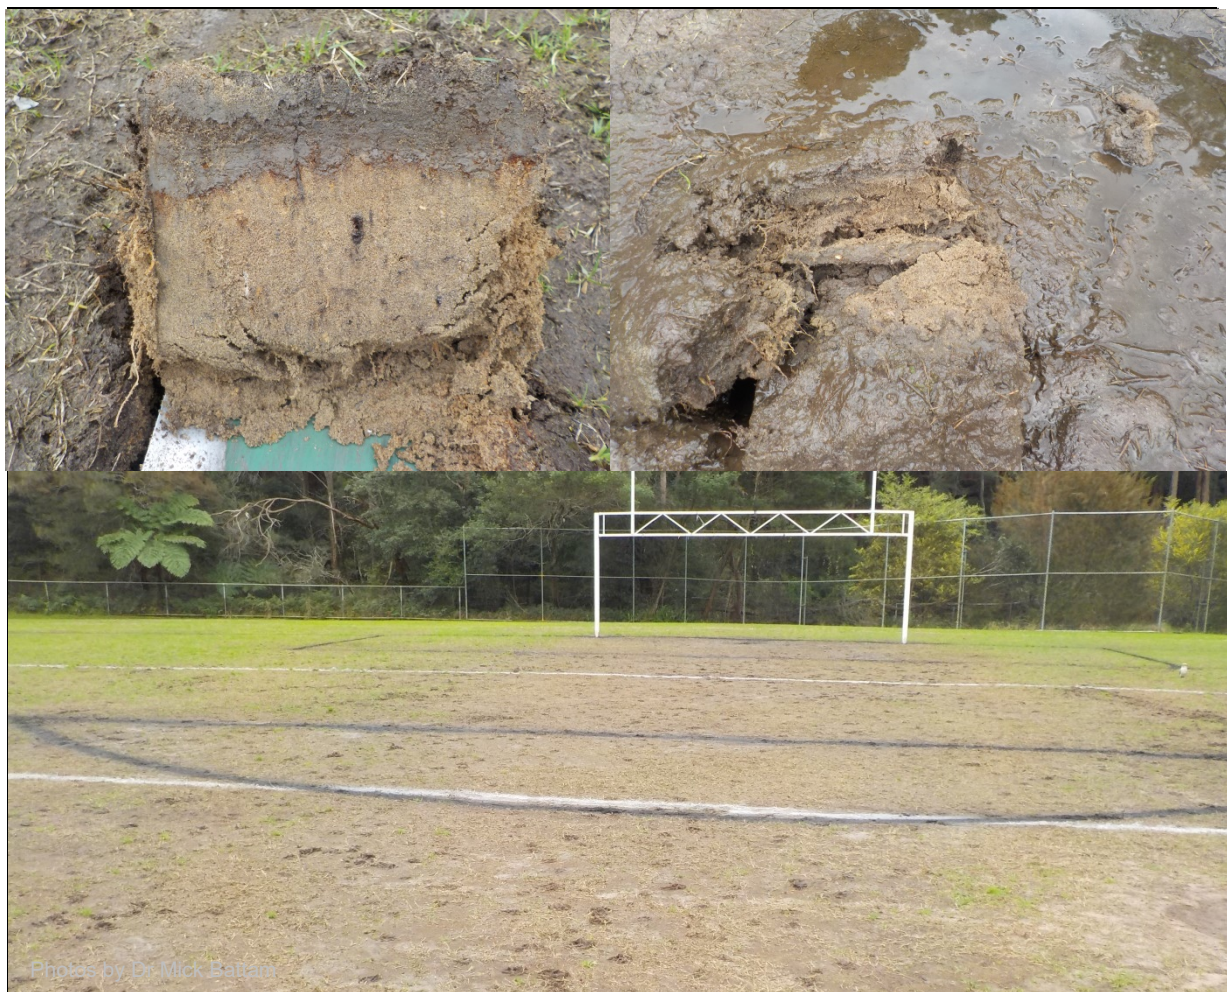
Figure A-1: The surface is soft following rain (lower) due to slow infiltration through the thin layer of soil imported to the site attached to turf rolls (upper left), with the underlying sand remaining relatively dry (upper right).
