Northern Suburbs Football Association: Playing field assessments

August 2016

Playing field assessments

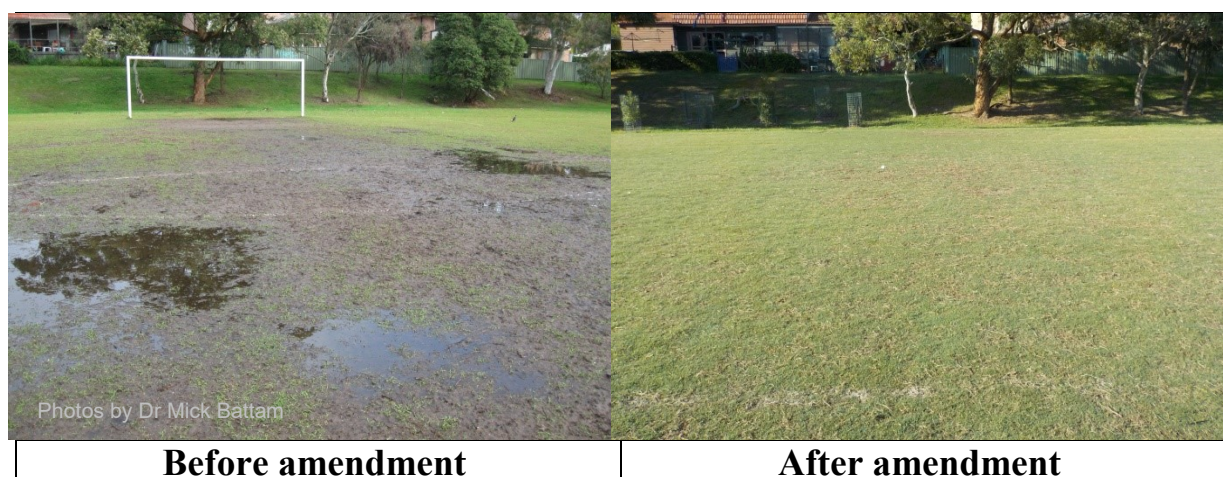
Figure A-4: The impact of amendment works on the October condition of Kareela no. 4 sporting field which receives about 50% more wear than Barra Brui Oval.

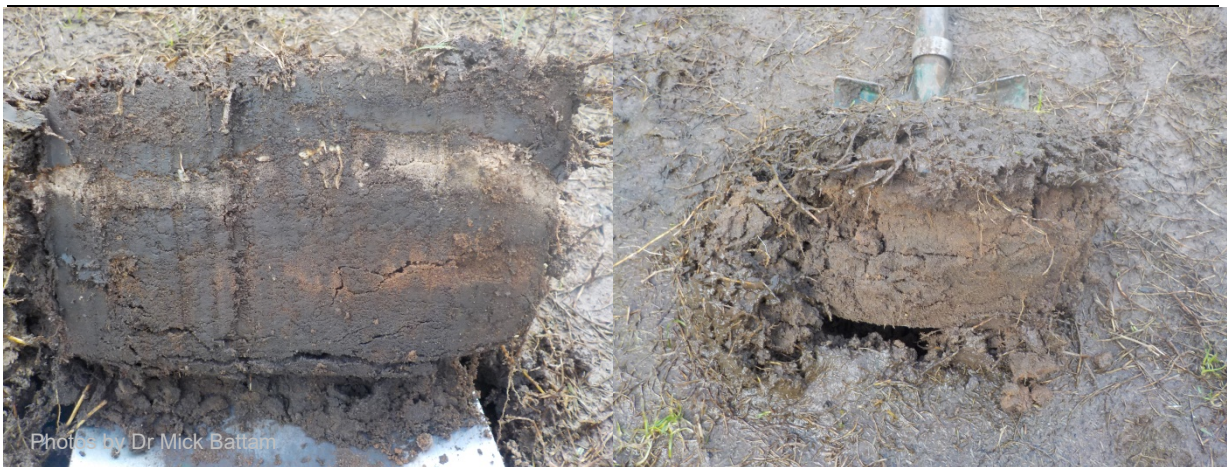
Figure B-1: The soil is highly layered in some locations (left), with the surface remaining soft after rain due despite the underlying soil being relatively dry (right).

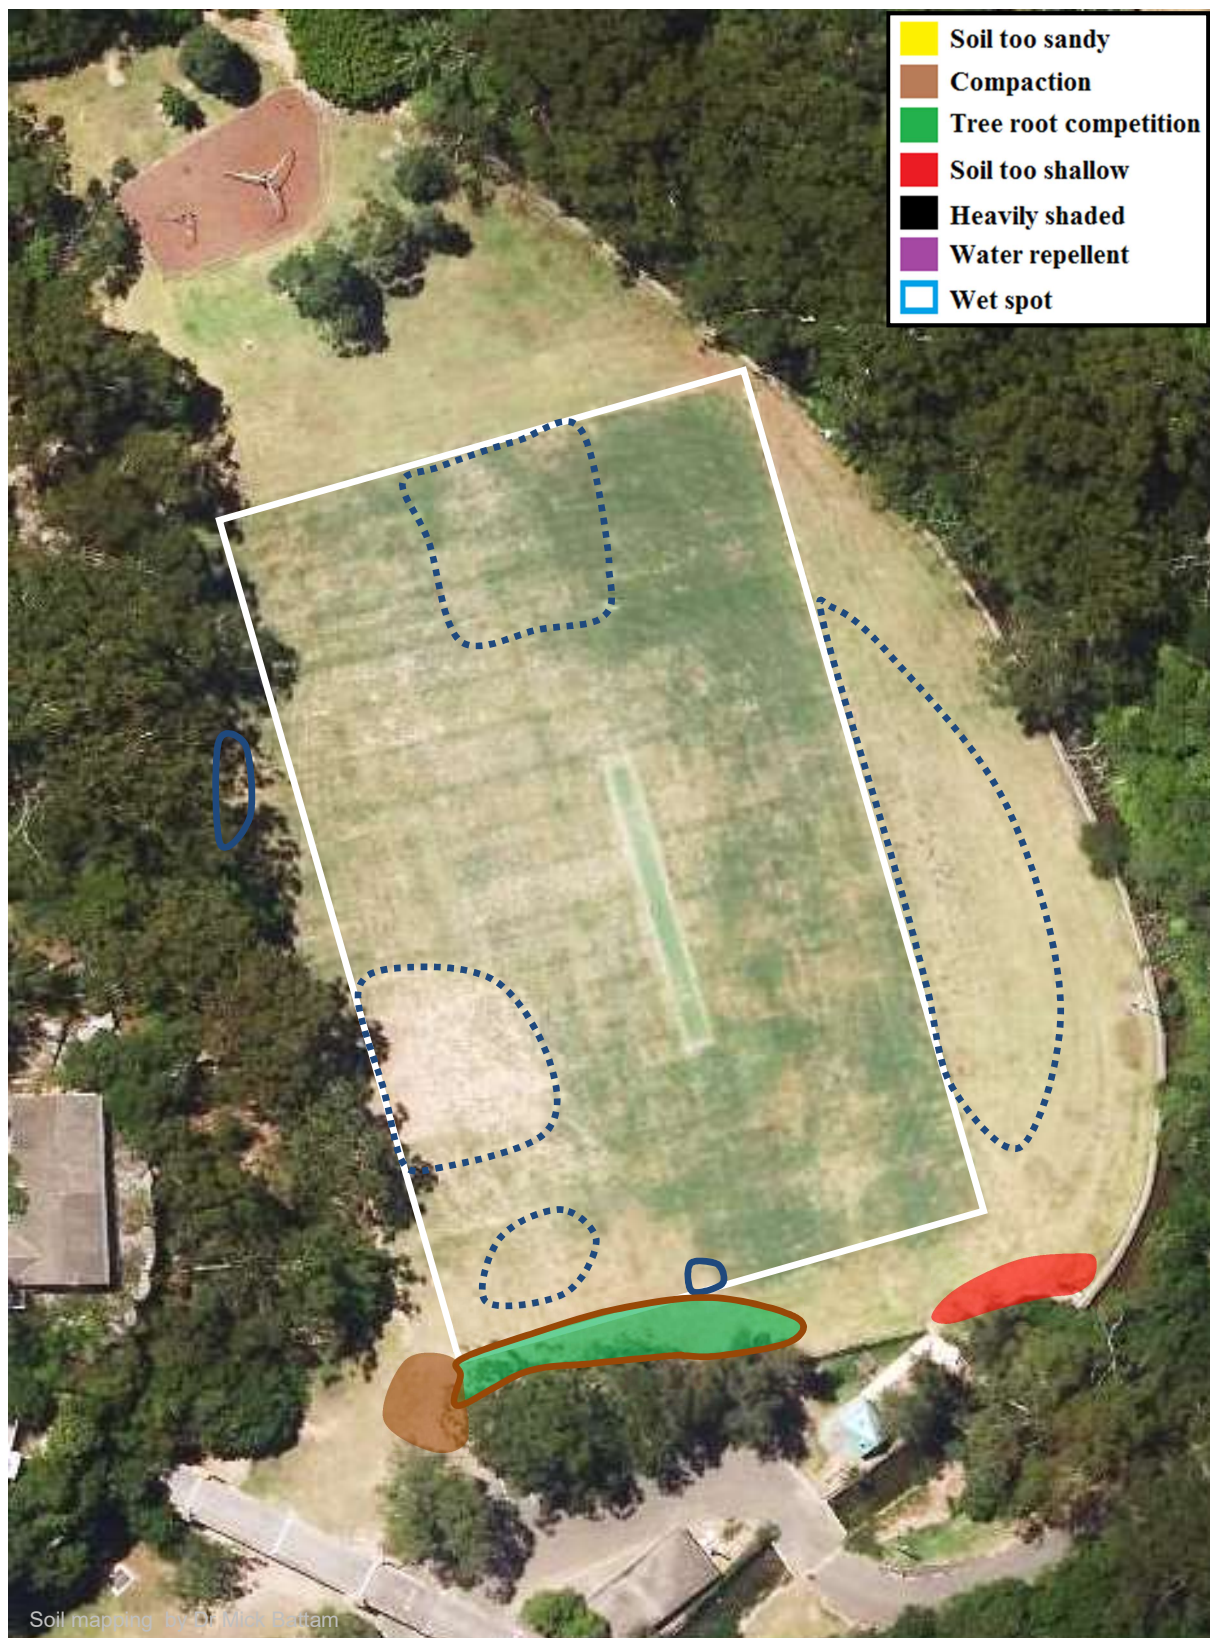
Figure B-2: Bob Campbell Oval showing factors limiting turf growth. Six Maps image.

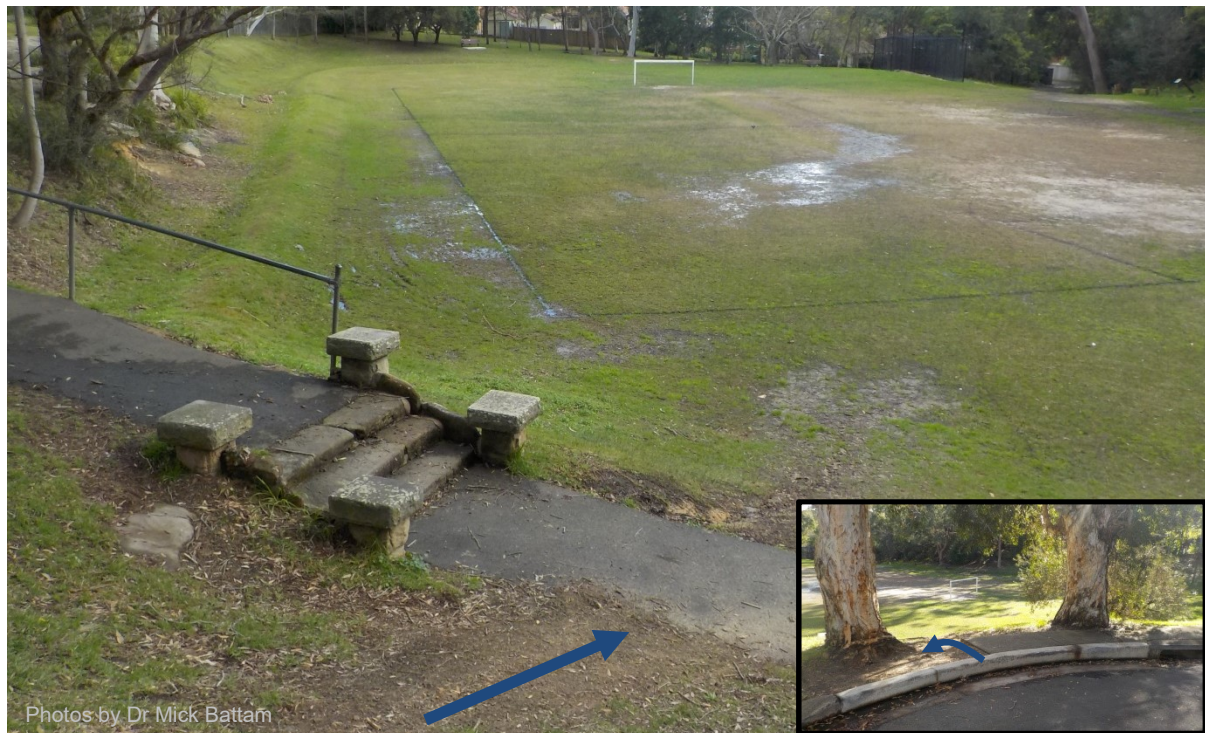
Figure C-1: Waterlogging at the eastern end of the field due to the gutter in street overflowing (insert) so water runs onto the field.

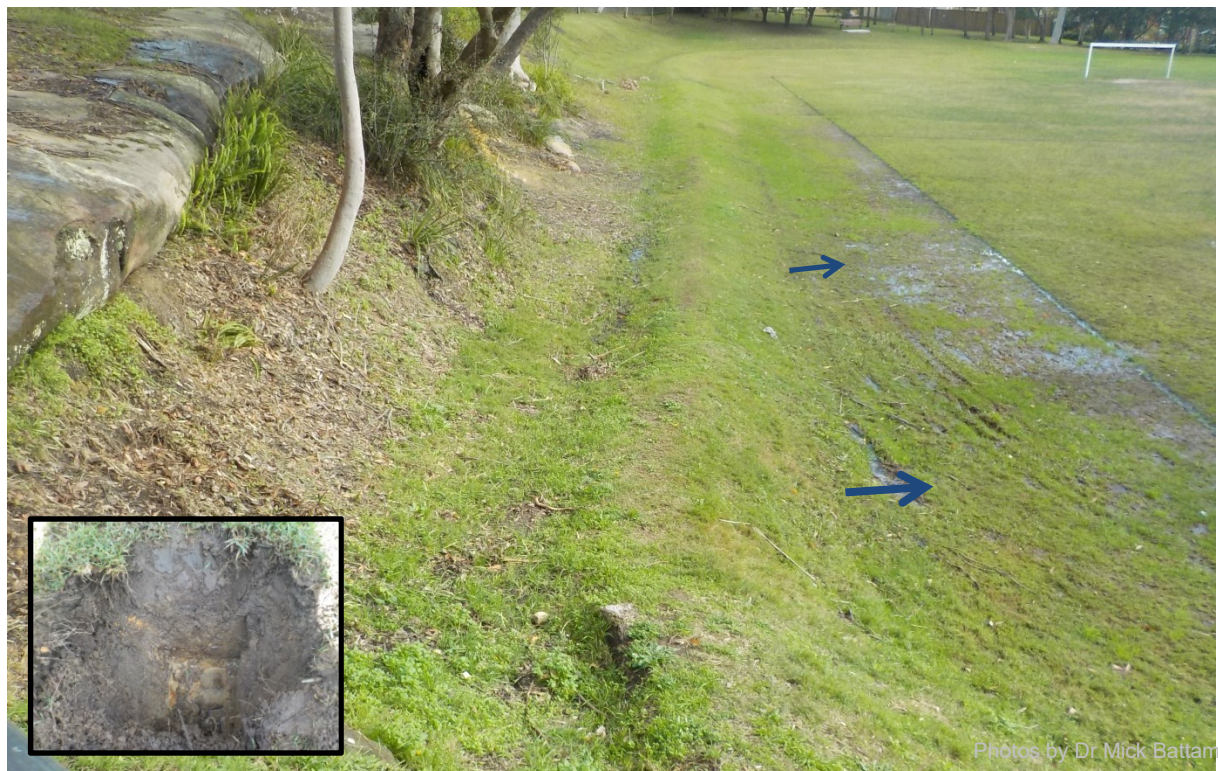
Figure C-3: Some of the water intercepted by the southern swale soaks into the soil until it reaches the subsoil (insert) and then moves downslope and seeps out of the embankment and onto the field. This could be overcome by installing a curtain drain within the swale in accordance with the design provided in Appendix K..

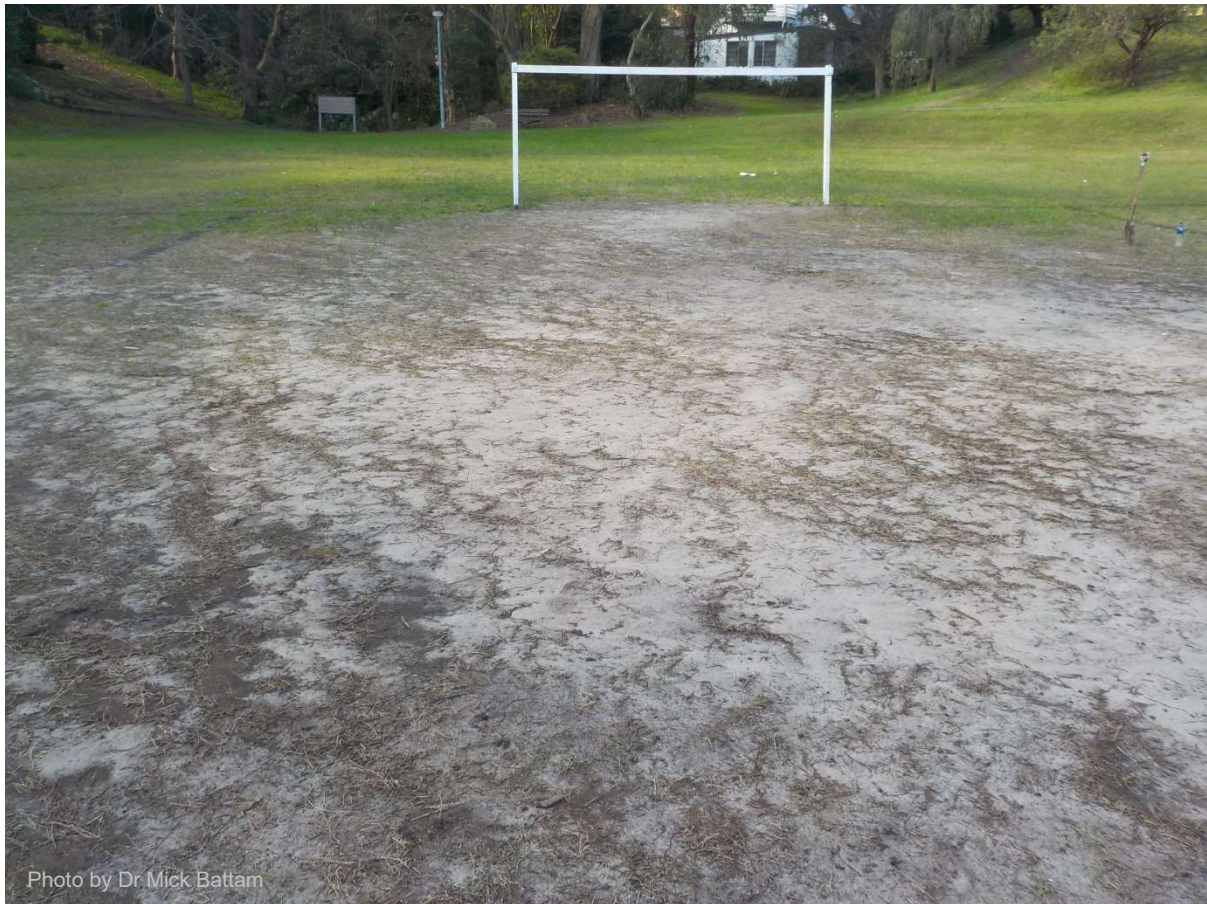
Figure C-4: Very thin cover was observed across large sections of the site.

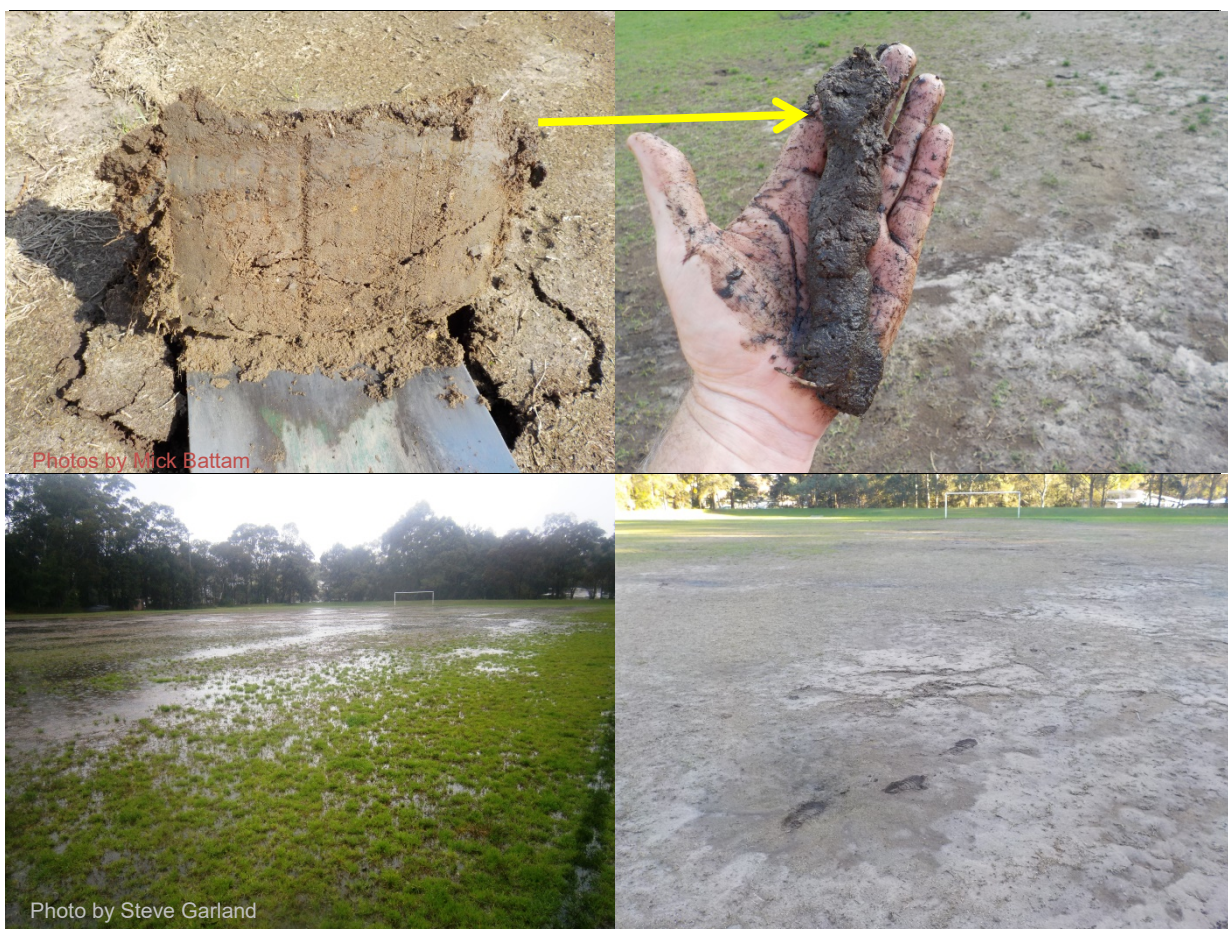
Figure D-1: A thin layer of clay loam or light clay overlies the sand loam soil (upper) and has likely been imported to the site attached to turf rolls. As result there is slow infiltration into the soil (lower left), leaving the surface soft after rain (lower right).

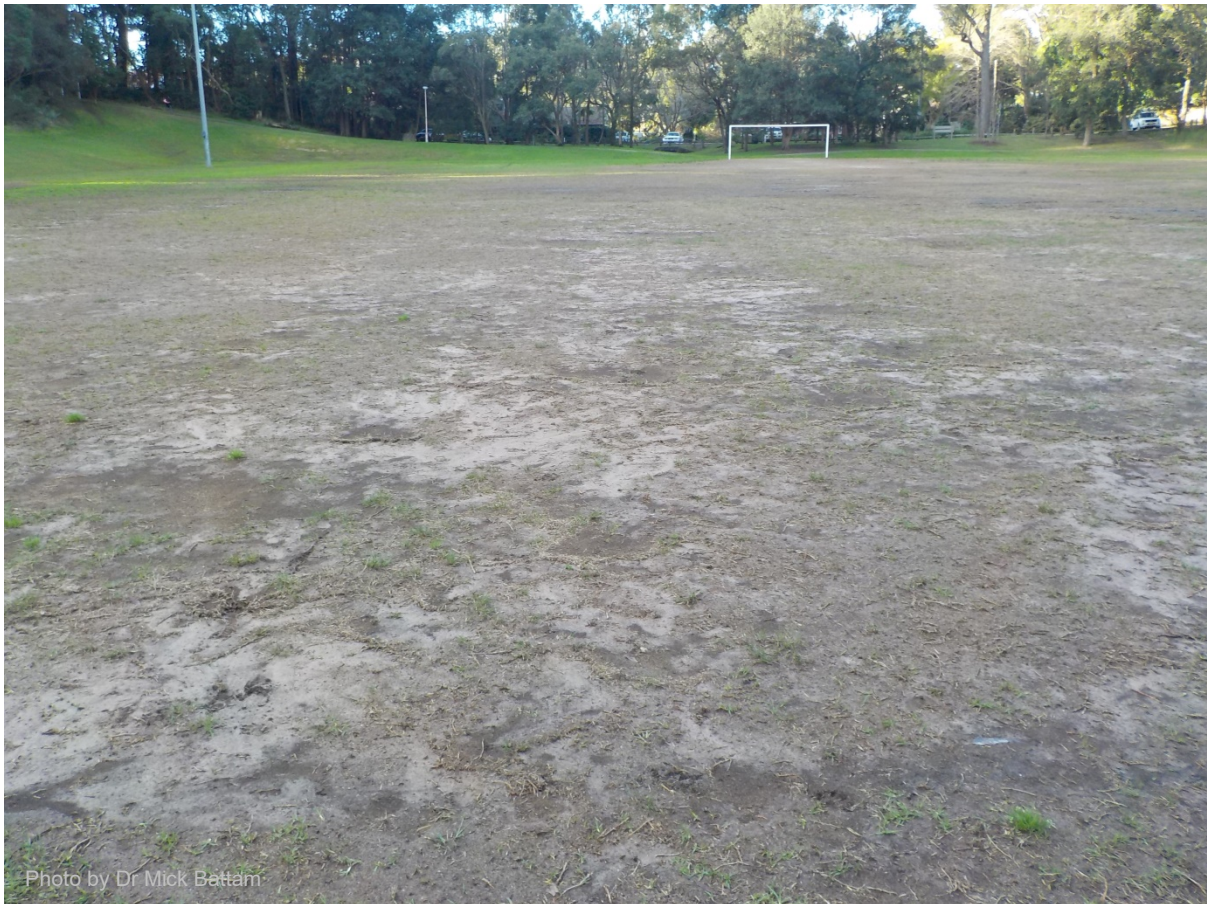
Figure D-4: Thin cover was observed across the field at the time of the inspection, but much of this will recover.

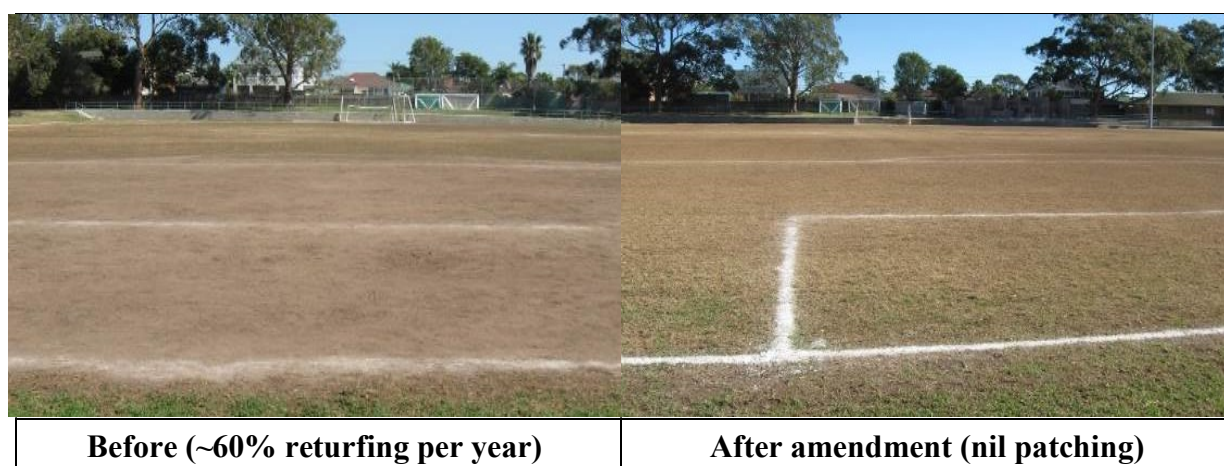
Figure D-5: Impact of similar soil amendment works on Gymea Bay Oval which receives about 50% more wear than Norman Griffith Oval and is likely the most intensely used field in Australia. Both photos were taken in the first week of August at the end of the winter sport season.

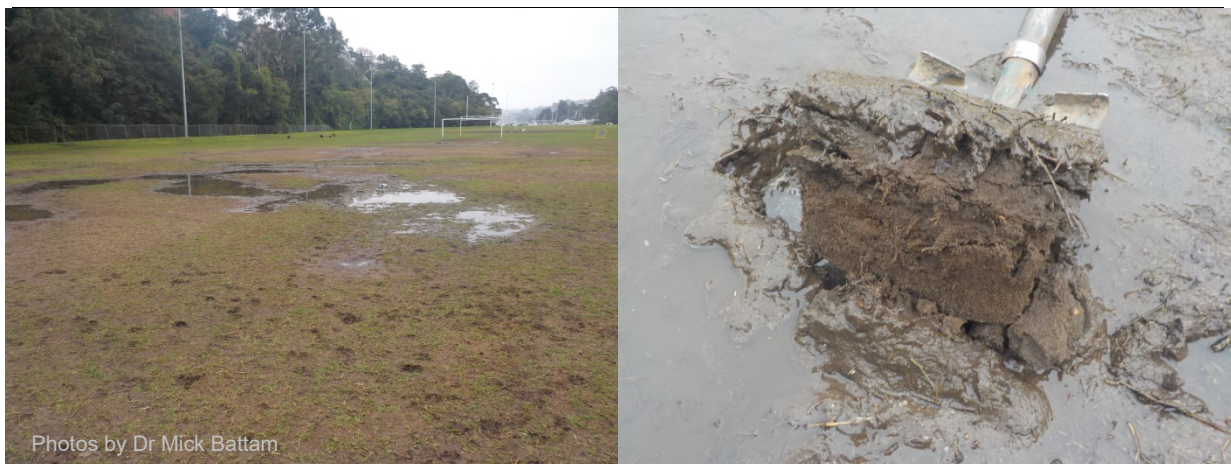
Figure E-1: Water lying in the numerous depressions in the field (left) due to slow infiltration through the surface, with the underlying soil being relatively dry (right).

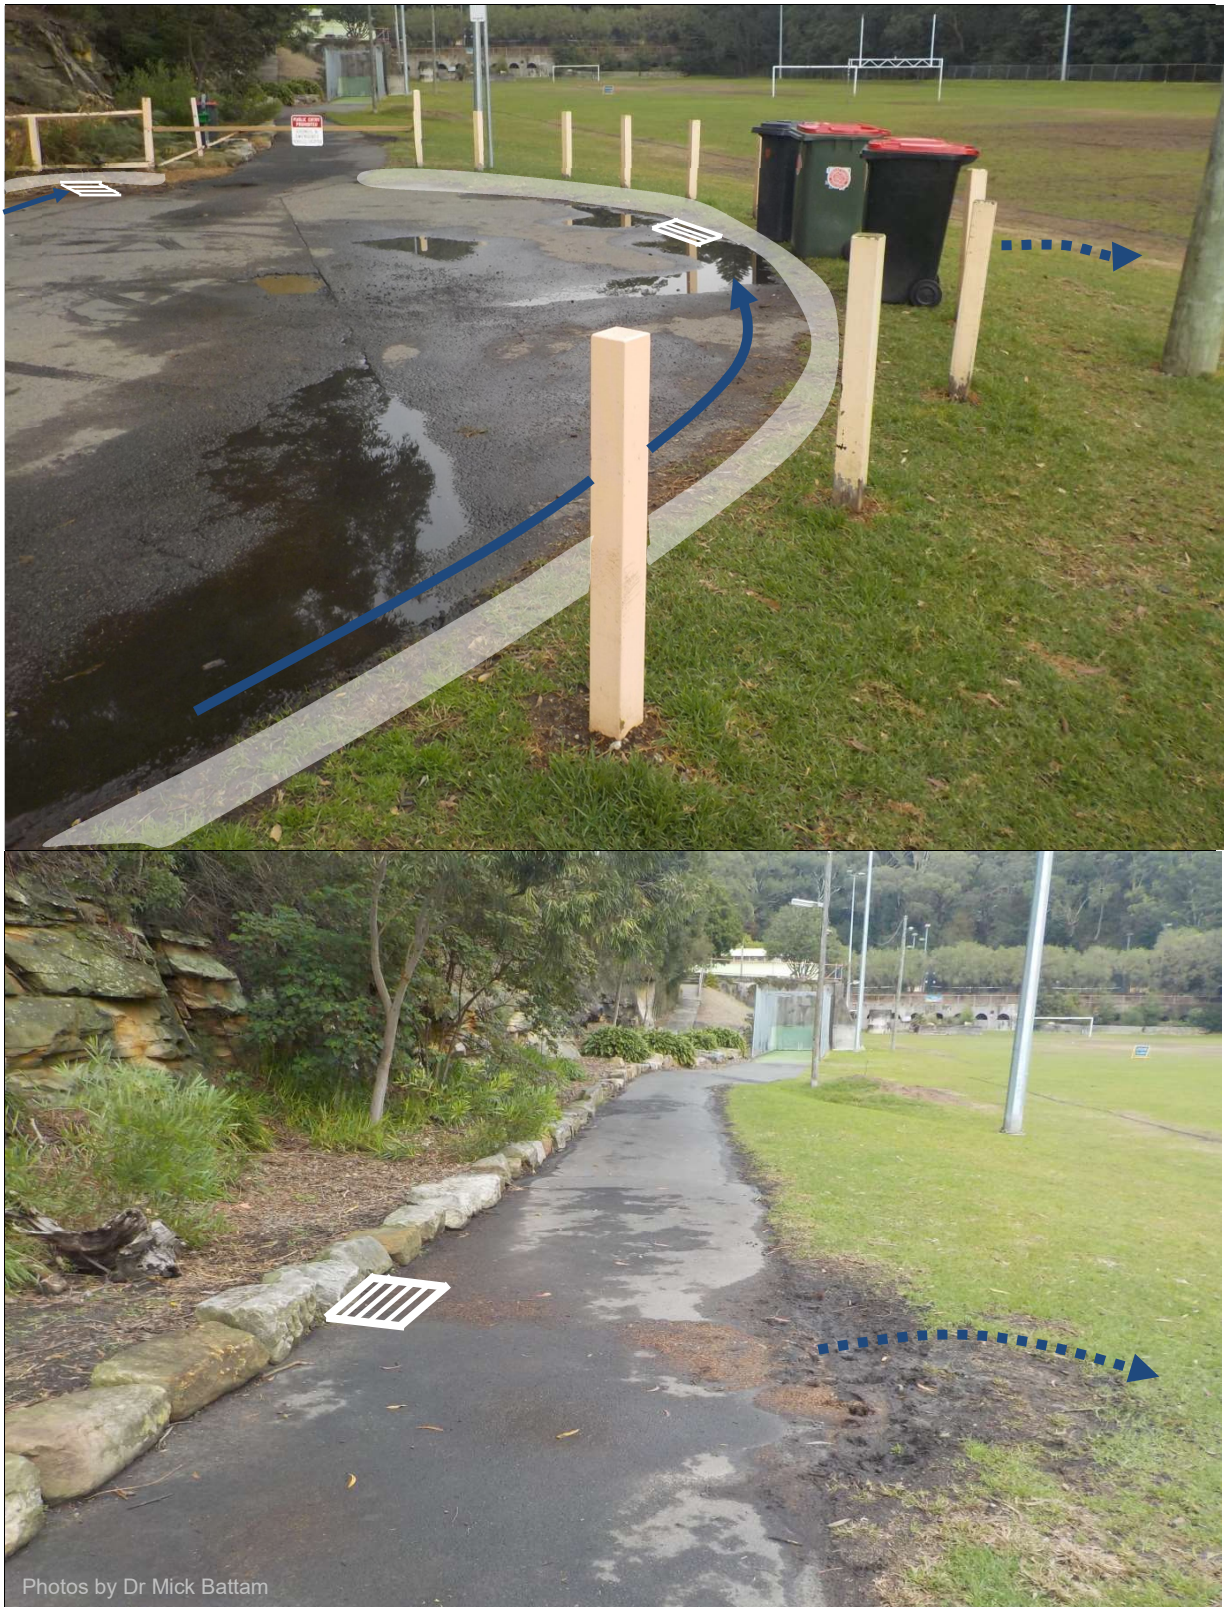
Figure E-3: Water running onto the fields (dashed arrows) that should be intercepted using surface pits, with a gutter or dish drain needed to divert water into the pits at the end of Denos Lane. It may also be necessary to install a dish drain or speed hump to prevent water running through the vehicle entry gate and onto the fields.

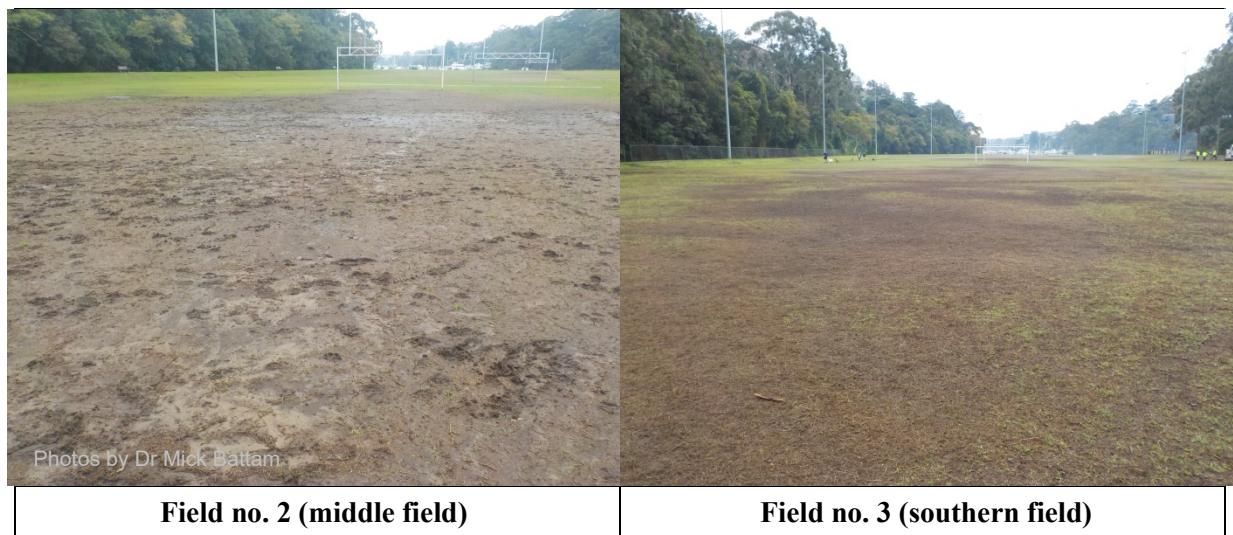
Figure E-5: Thin cover was observed across large sections of the site.

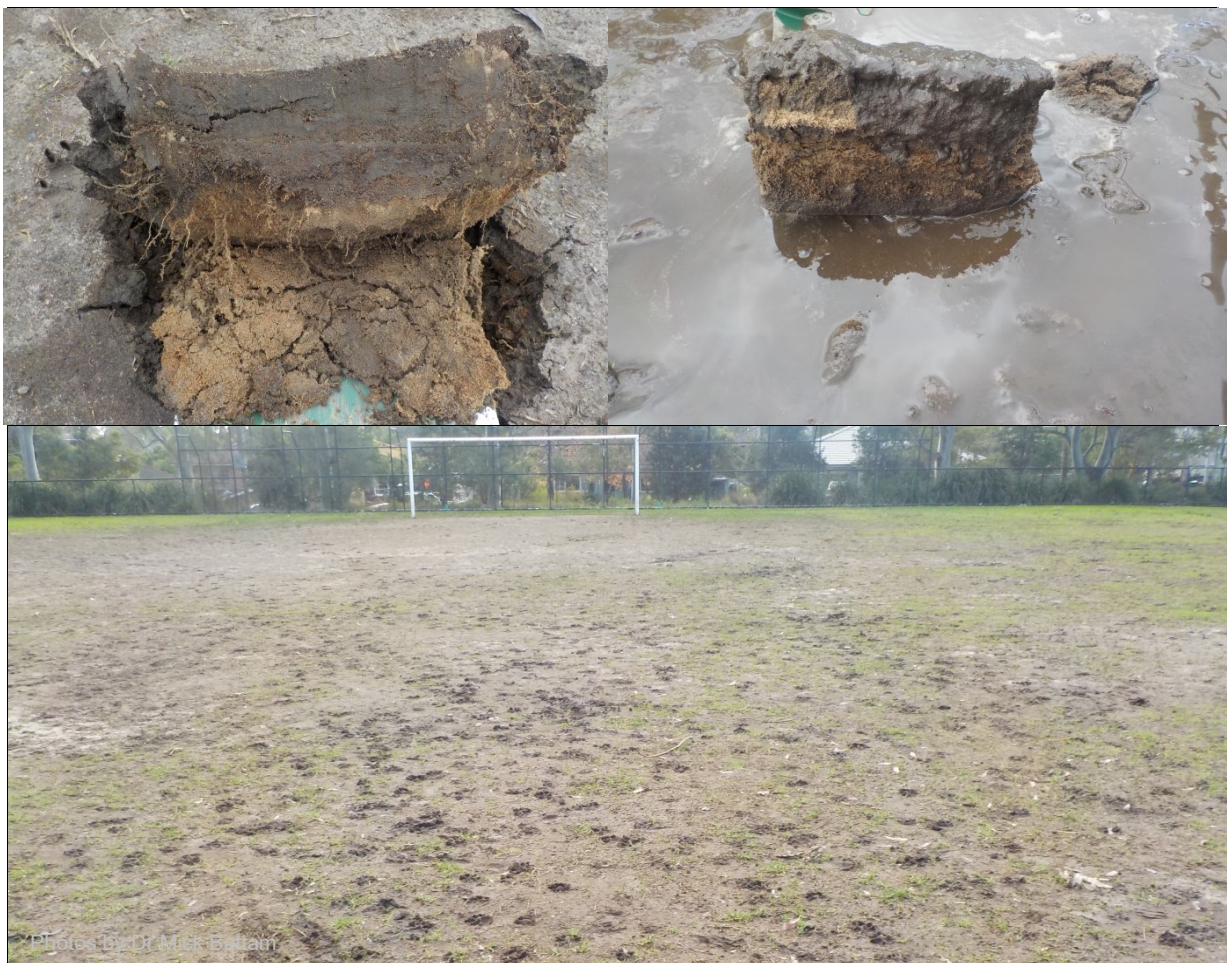
Figure F-1: The surface is soft following rain (lower) due to slow infiltration through the topsoil, with the underlying sand remaining relatively dry (upper).

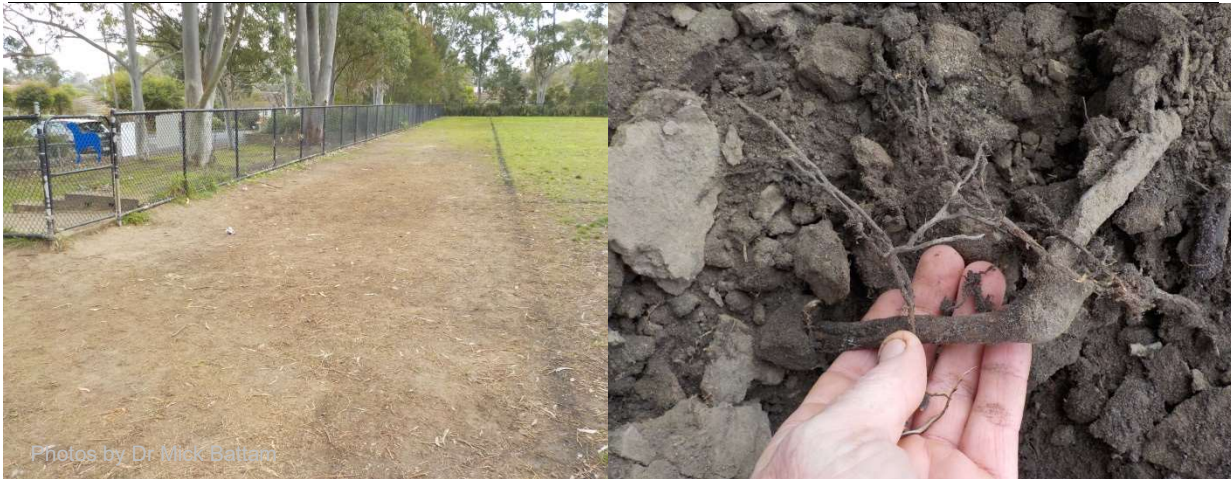
Figure F-3: Thin turf was observed along the perimeter of the field (left) due to competition for water and nutrients by tree roots (right).

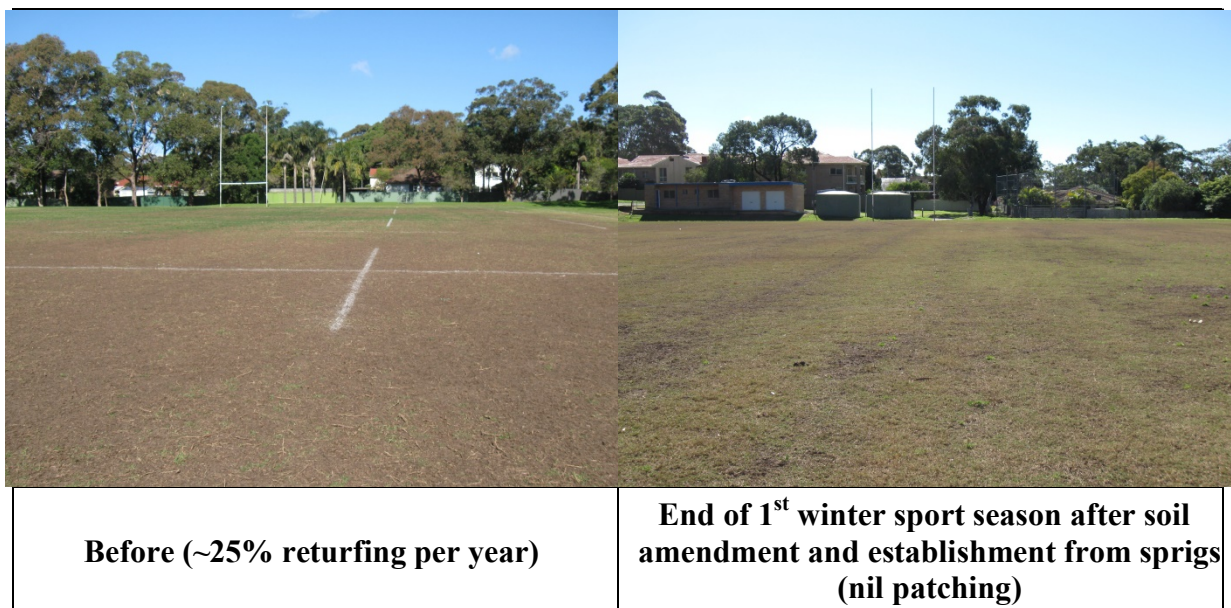
Figure F-5: Impact of amendment works on John Dwyer Oval (receives slightly high wear levels to Queen Elizabeth II Reserve) which was re-established from sprigs. Both photos were taken in the first week of August, with much better cover observed at the end of the second winter sport season.

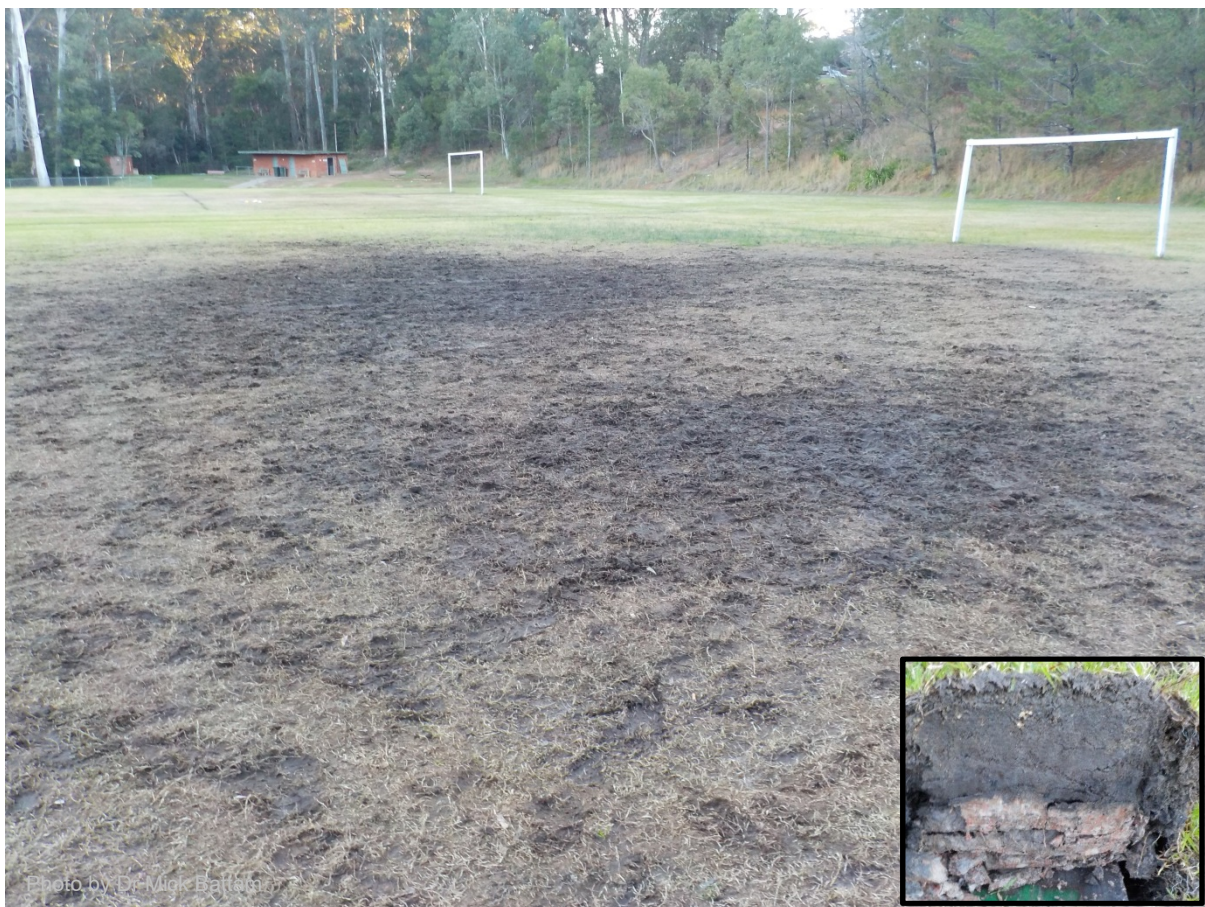
Figure G-1: Waterlogging in the northwest goal box where the soil was very shallow (insert).

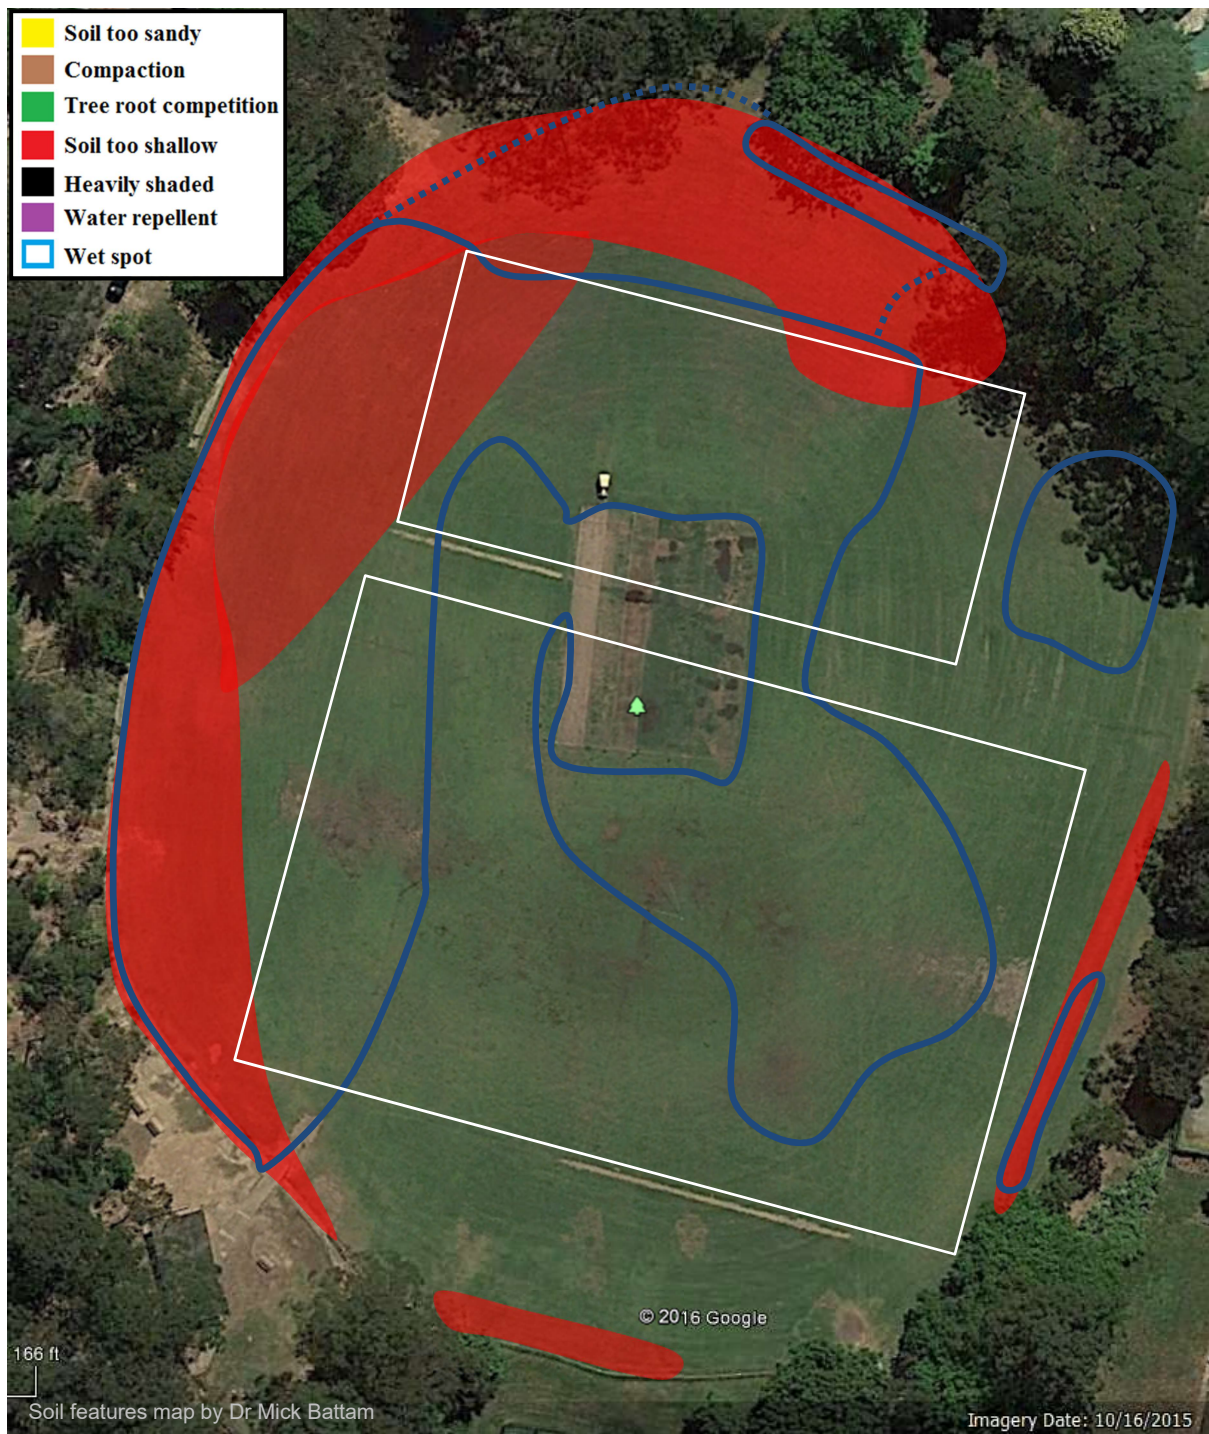
Figure G-2: The Glade Oval showing factors limiting turf growth. Google Earth image.
